APPLE
Home Inspection Service

Inspection Report

Property Address: California Ave. Santa Monica

Scope: Limited Visual Inspection

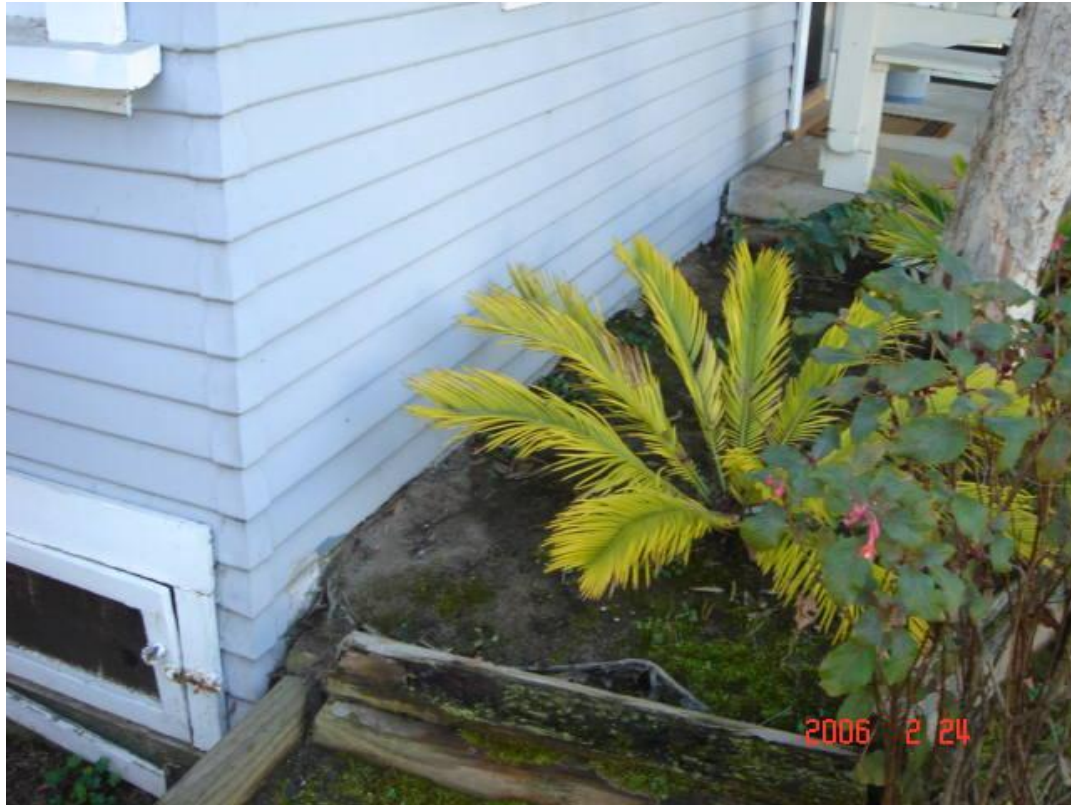
13. A section of electrical wiring is laying on the ground under the house and should be raised up off the ground and attached to the floor frame.
14. The planter box area at the front of the house is against the side of the house. There should be a two inch gap to prevent possible rot damage to the side of the house.

The planter box too close to the wood siding. (lead paint?)

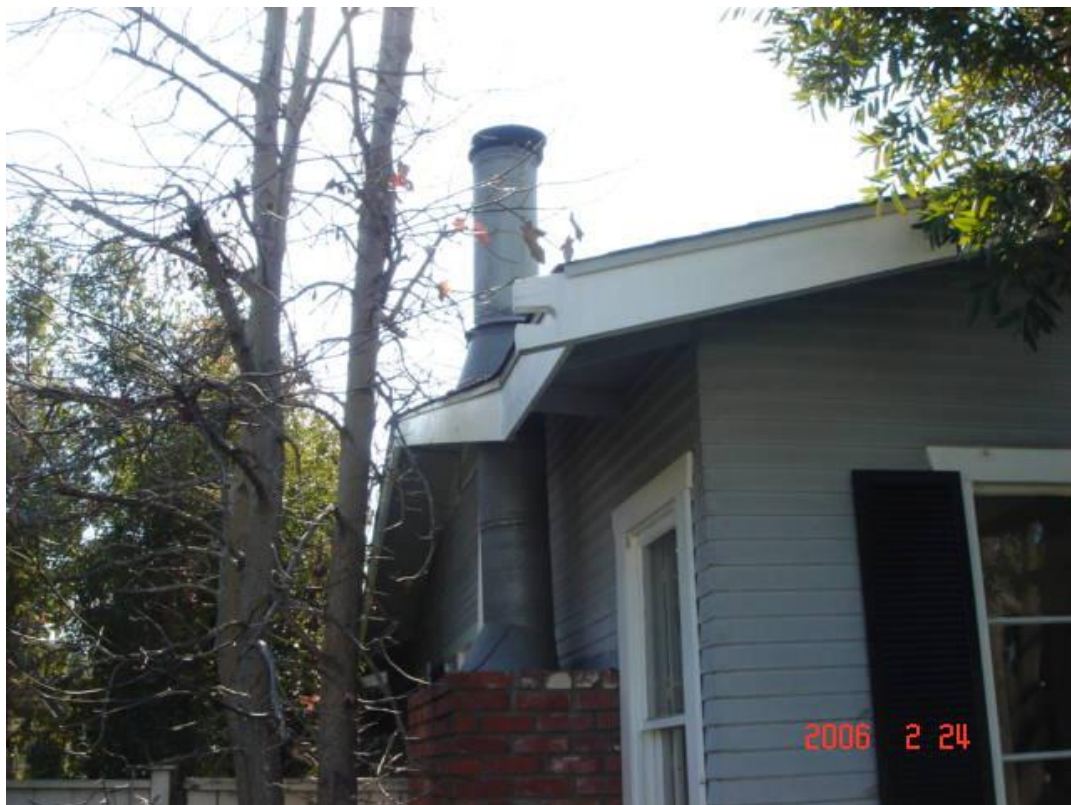
25. Tree limbs are burnt or charred next to the fireplace top, have the adjacent tree cut back or removed.
26. The gap where the gas pipe extends through the fireplace firebox wall needs to be sealed with a special high temperature grout. This will prevent the possibility of sparks entering back behind the wall where combustible material may be.

The fireplace and tree to close to the spark arrester.

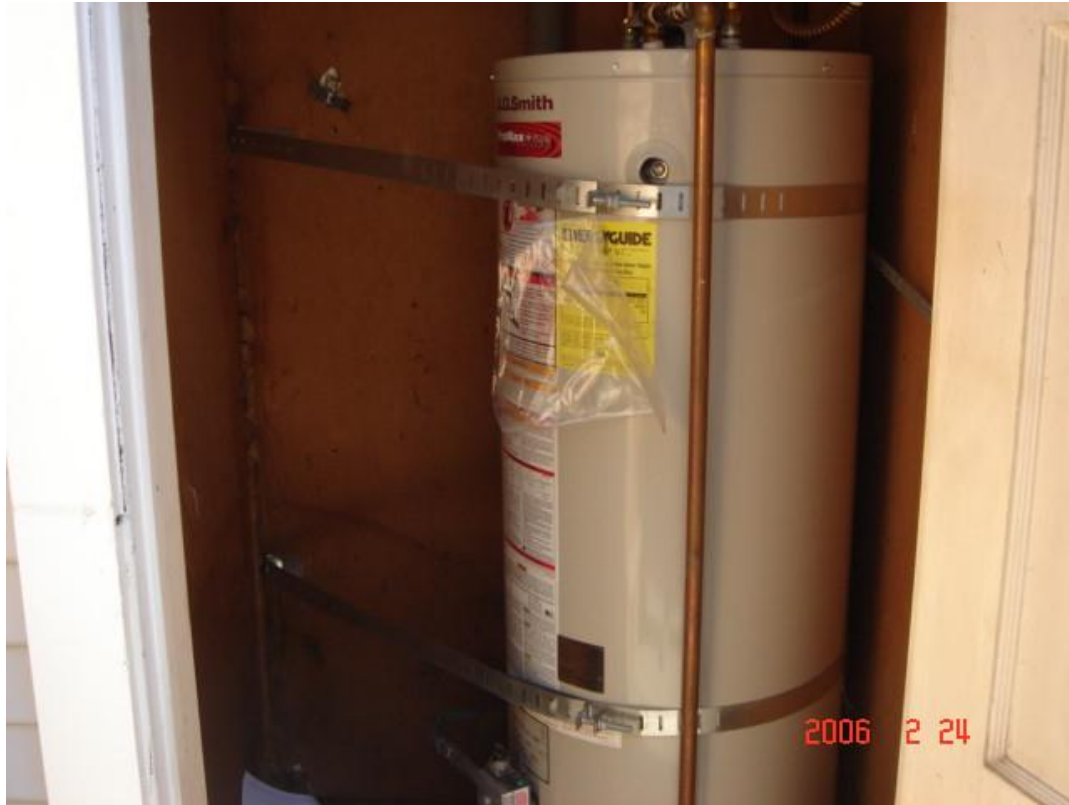
15. The wood siding of the house is painted wood. At this time period, lead paint was used. Lead paint is considered a hazard, read about lead paint.
16. The earthquake strap around the hot water tank is improper. The wide angle of the strap will not keep the tank from moving.

The earthquake strap to wide around the tank.

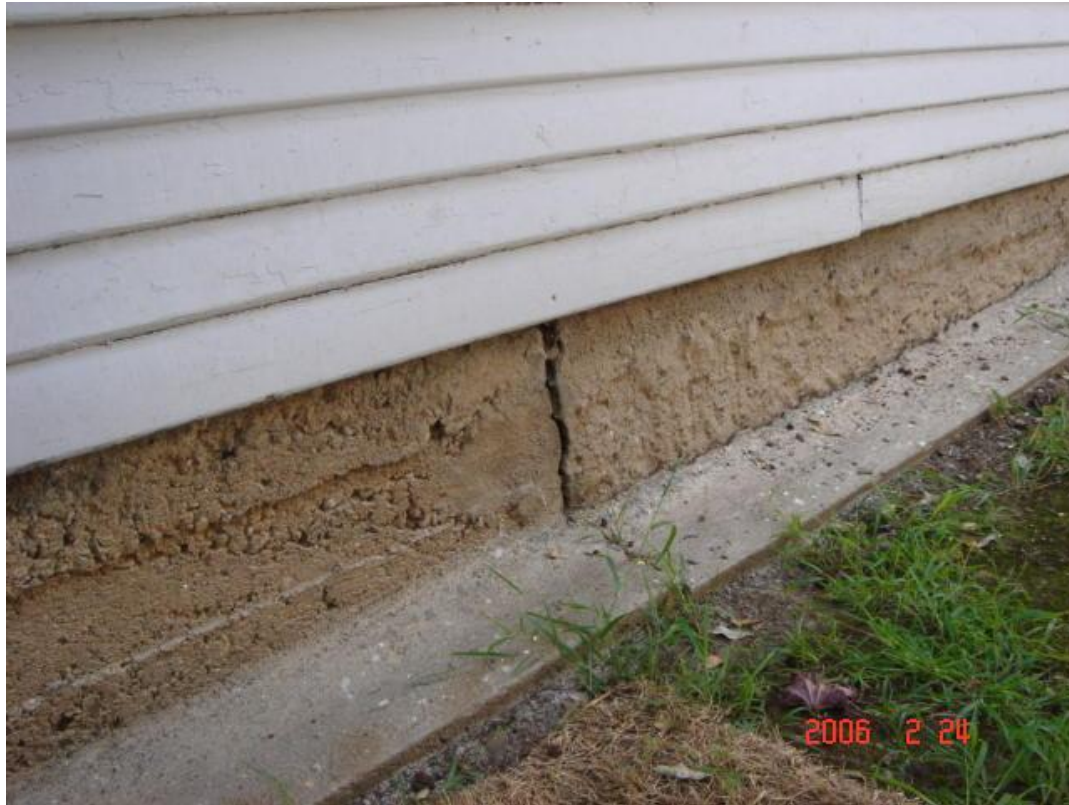
4. The sill plate is loose from along the rear east foundation. There are several vertical cracks in the concrete foundation.
5. Have a foundation contractor, engineer or trades person, further inspect, comment, make recommendations and repair or replace as may be needed.

A crack in the concrete footing.

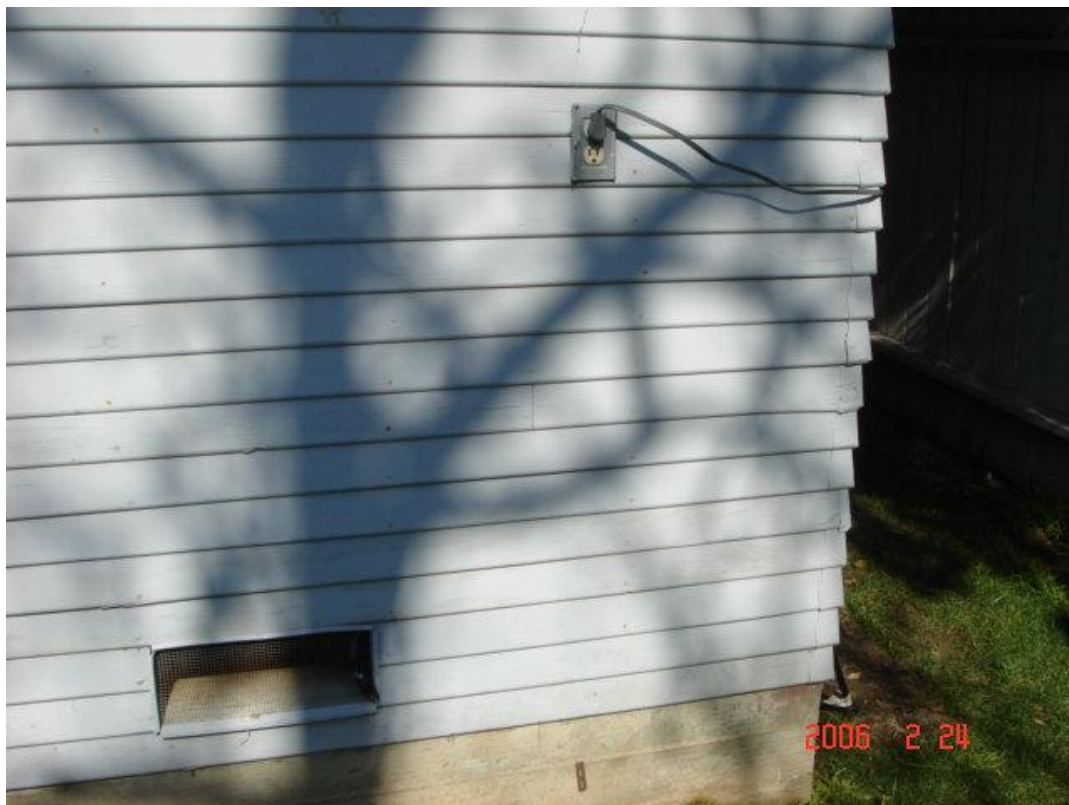
24. The sprinkler timer is plugged into an interior type outlet that is not weather protected. There is an electrical wire extension coming out of a foundation vent screen at the rear of the house, the cap covered wires should end in an approved box for safety.

The unprotected outlet and wire at the foundation vent needing a box.

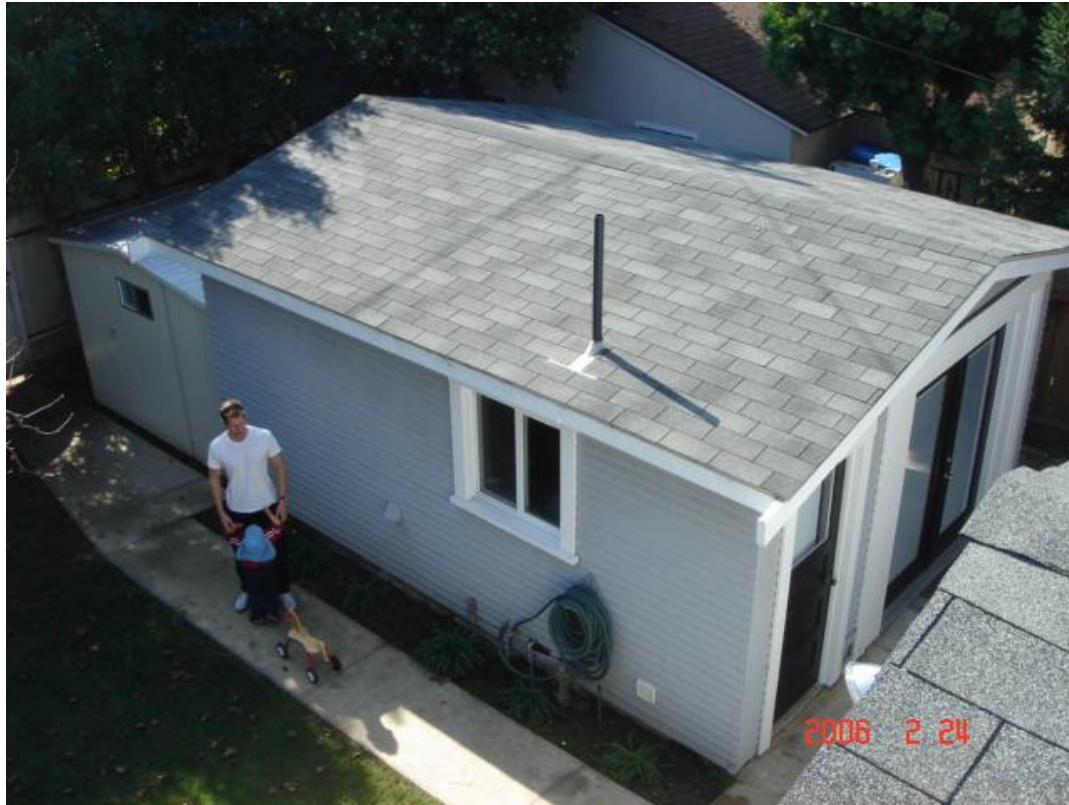
19. The rear section of the house appears to be an addition, check the building permit history for proper permits.
20. The garage has been converted to a living area. Usually a garage is required for zoning and city requirements. The interior floors slope out of level. I was not able to view under the floor to see and cracking or rot damage. The driveway slopes towards the converted garage and may pond water underneath. The floor would have to be removed to know or detect problems.

The converted garage.

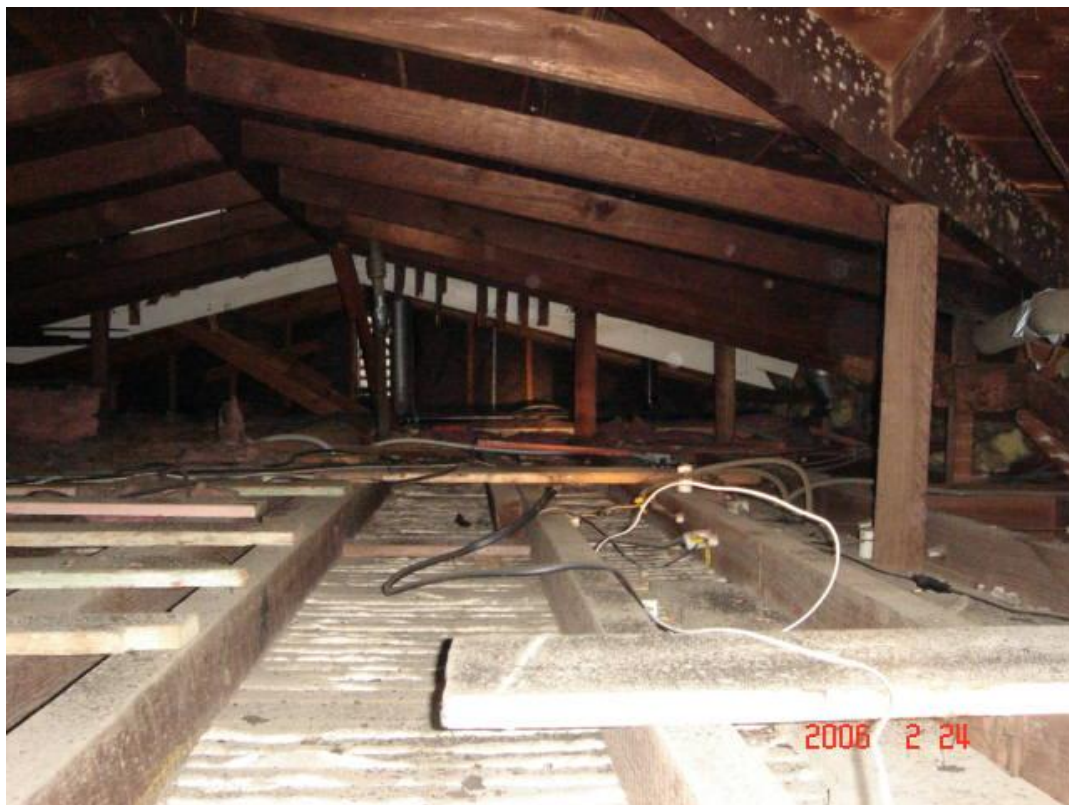
11. The metal storage cabinet above the floor furnace in the living room should be removed.
12. There is knob and tube wiring in the house (attic and foundation) This type of wiring is old and consists of wires separated by an air space and mounted between porcelain insulators. There is no protective conduit (pipe or sheathing protection) This type of wiring can easily be damaged and is not considered safe. Knob and tube wiring should never be covered with insulation, because the heat in the wire can't dissipate. Electricians usually recommend the removal of this type of wiring. Check with an electrician.

The attic, no insulation and knob and tube wiring needing replacing.

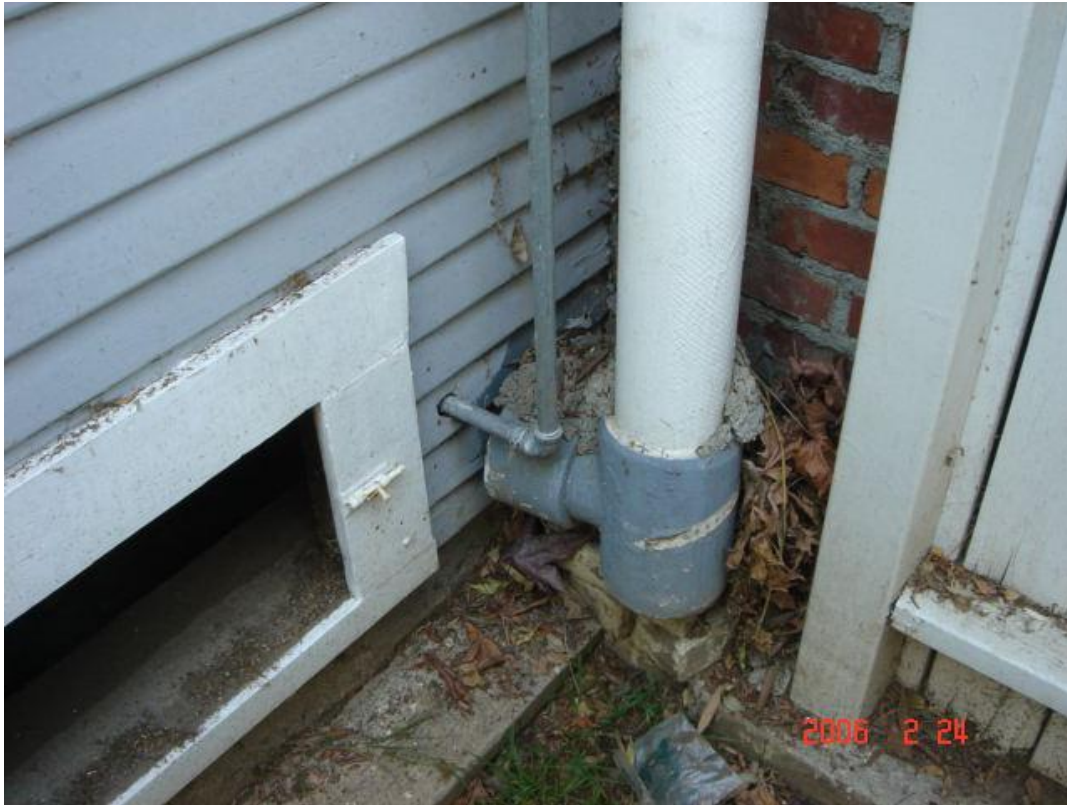
10. The vent box attached to the floor furnace in the front room is rusted open. All products of combustion dissipate under the house and seep up to the living area above. This could be a hazard. The transite asbestos vent pipe is disconnected at the side of the house by the fireplace. Have a plumber check and repair as needed. This is a safety or hazard condition.

The disconnected floor furnace vent pipe by the fireplace.

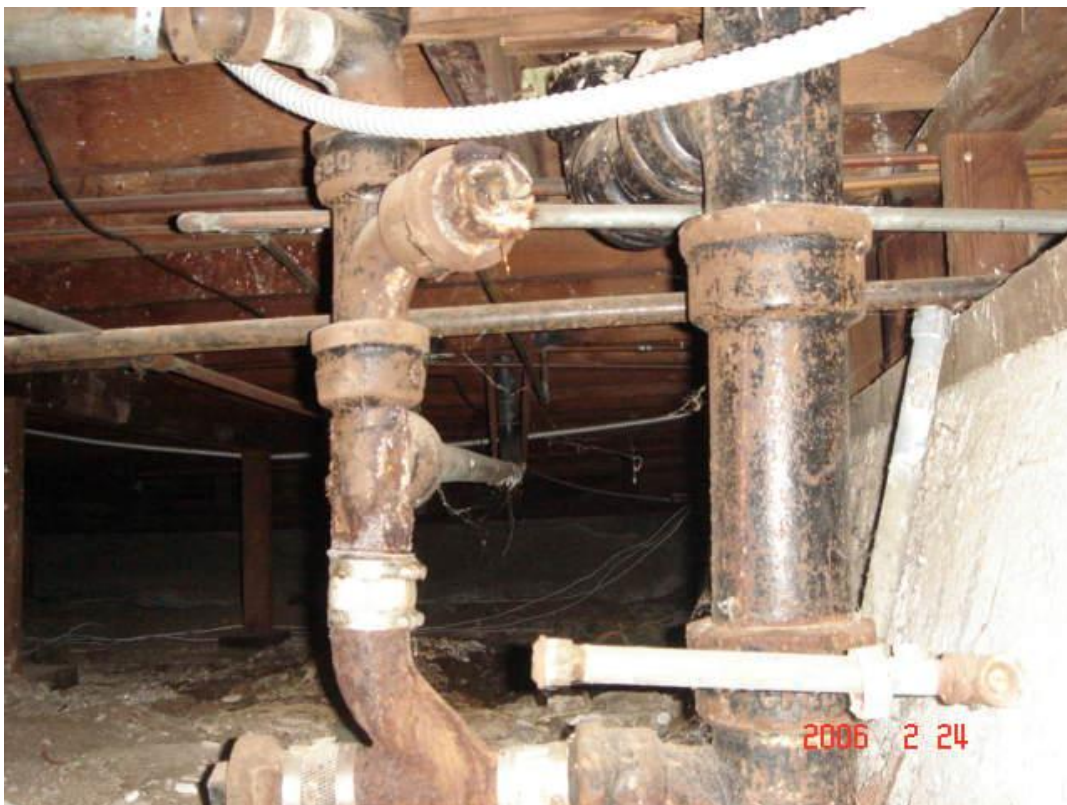
A section of corroded drain pipe.

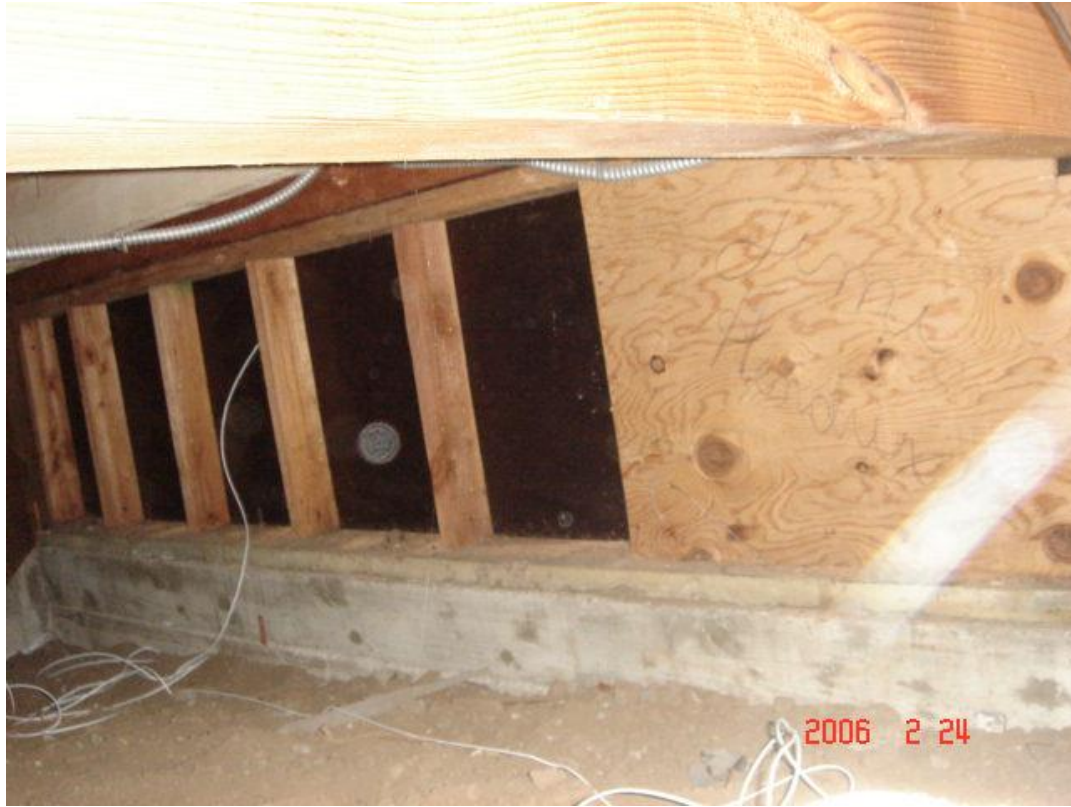
3. Some cripple walls have been added under the rear addition of the house. The cripple walls have been improperly installed. There is no blocking, some sections are loose.

Partial incorrectly installed shear wall support.

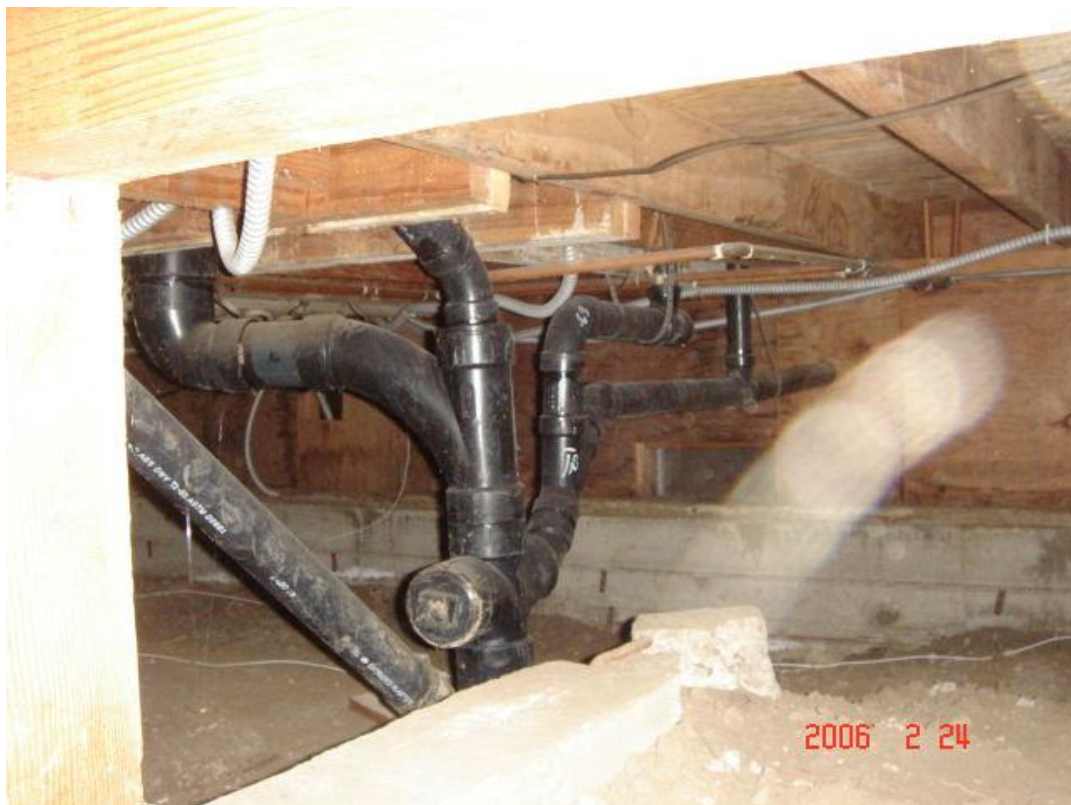
6. There are leaking corroded sections of plumbing drain pipe as viewed from under the house. Plumbing pipe fittings are not correct under the rear master bathroom. The drain lines above and under ground appear original and possible in need or replacing. Have a qualified plumbing contractor or trades person, further inspect, comment, make recommendations and repair or replace as may be needed.

Improper drain fittings under the master bathroom.

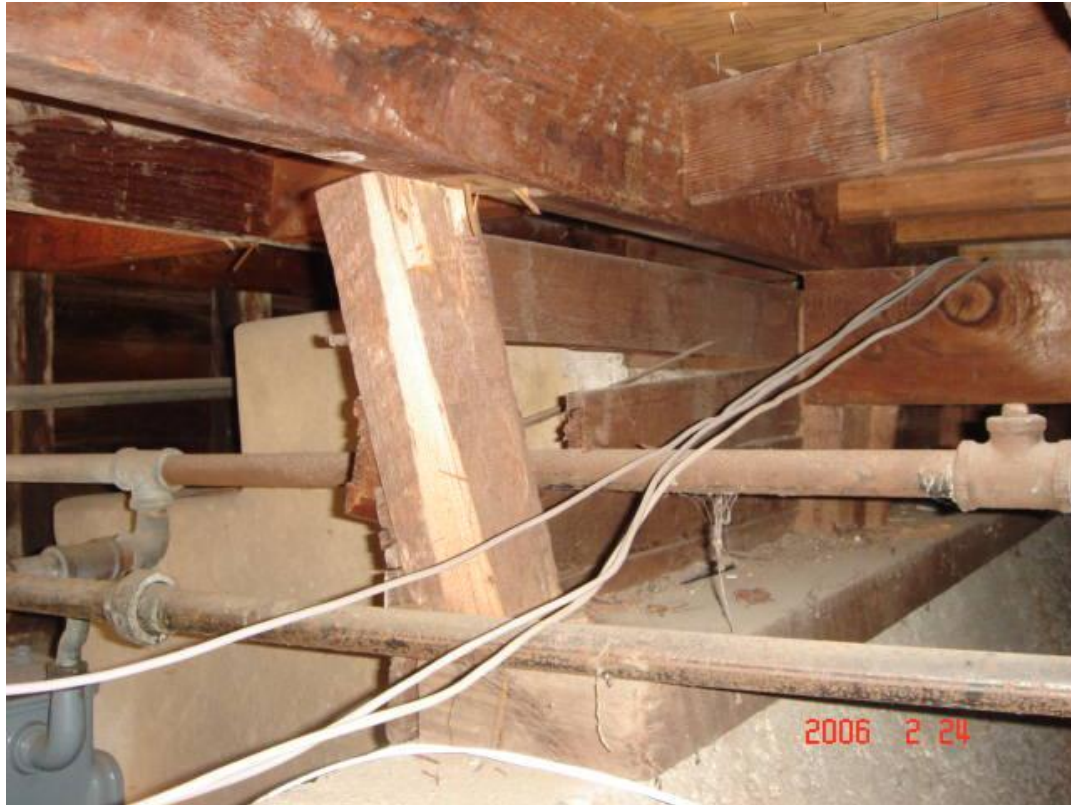
Loose cripple wall support.

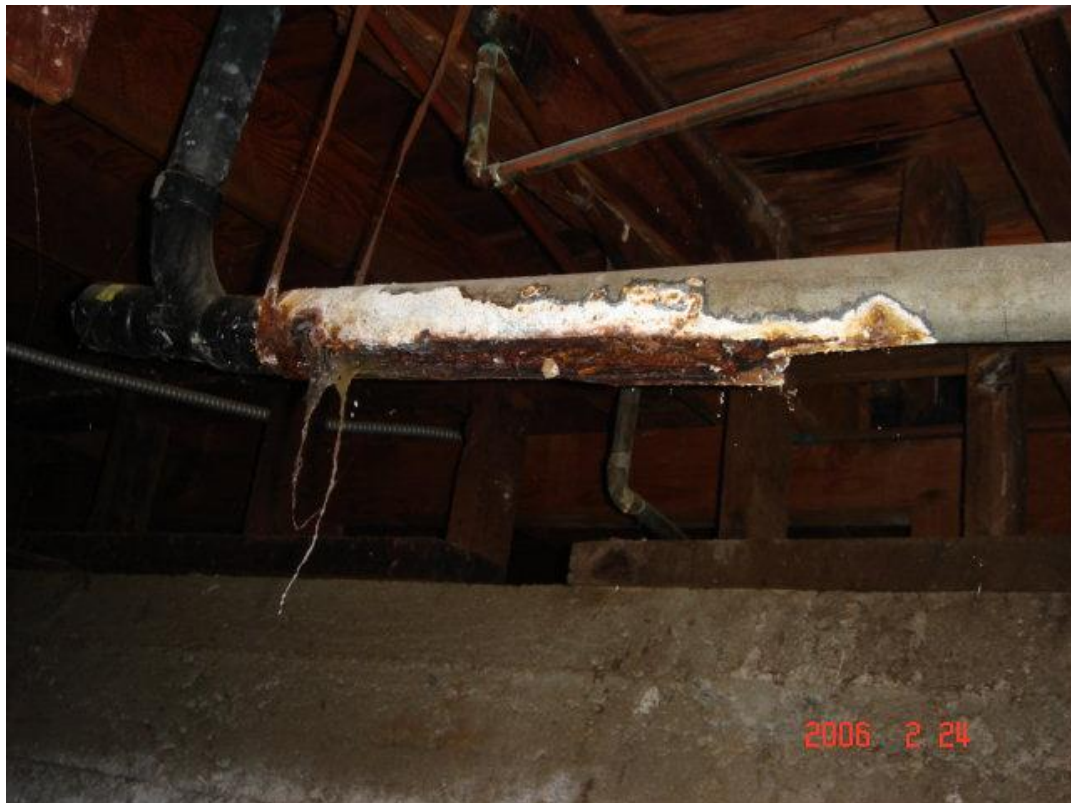
Corroded drain pipe, leaking to under the house.

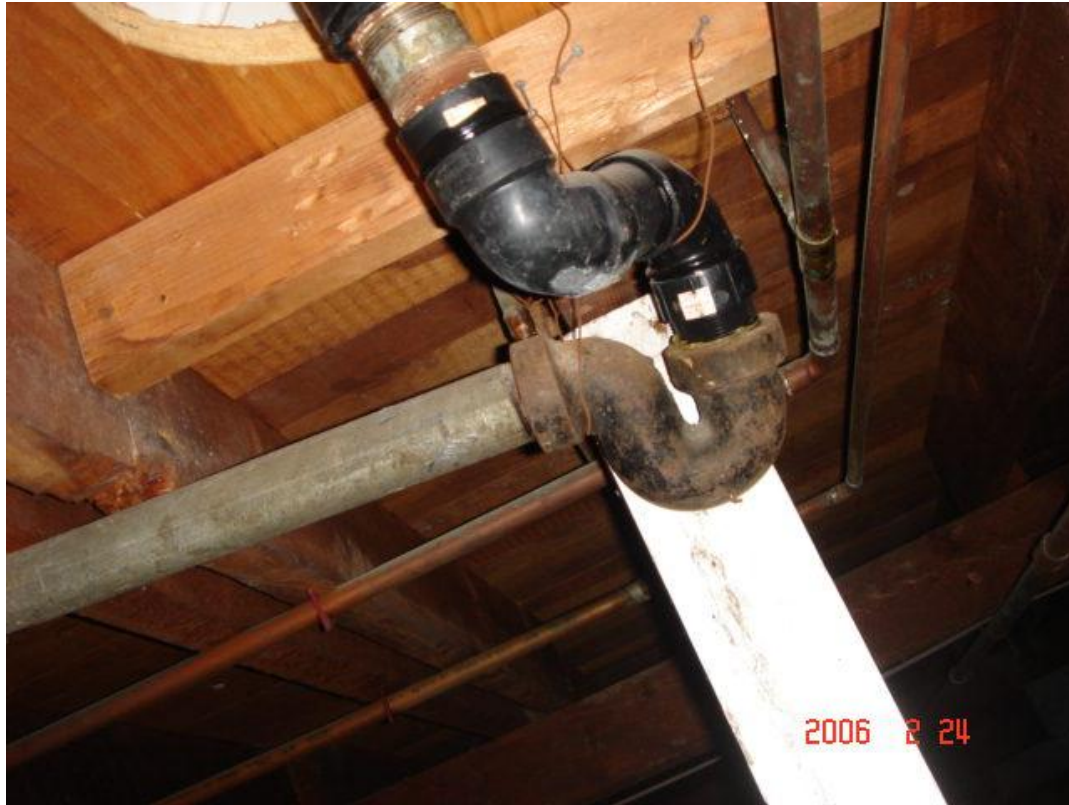
Improper drain fitting under the hall bathroom.

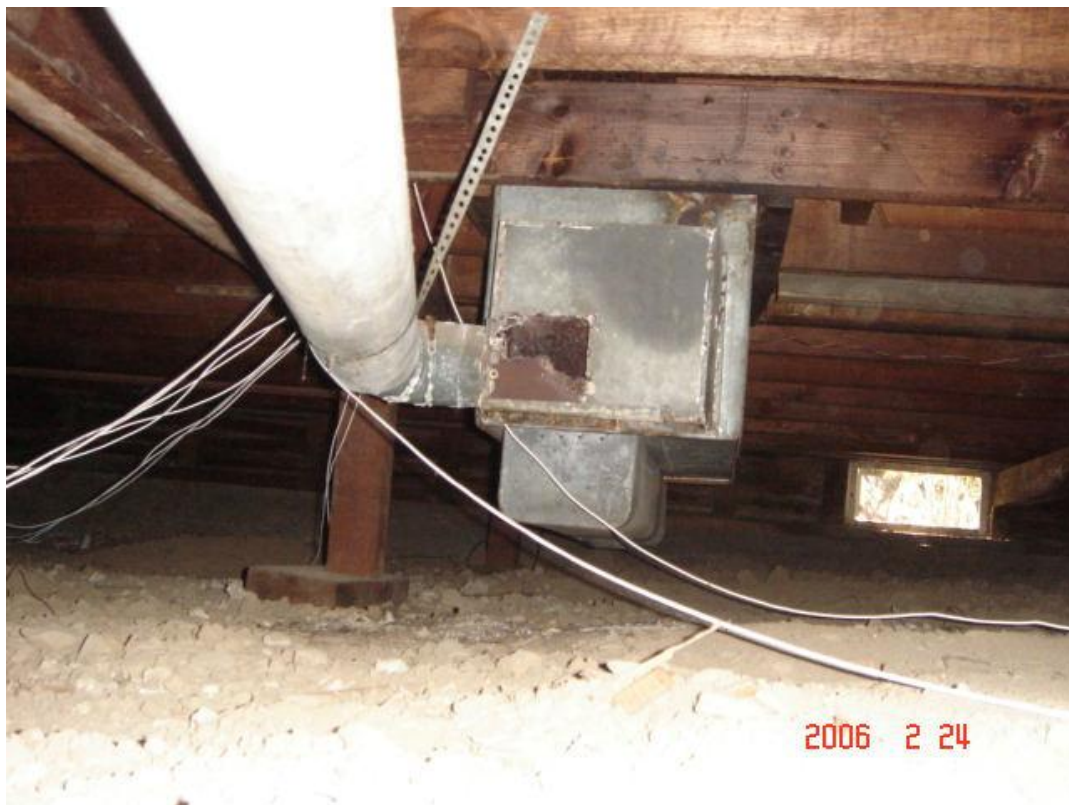
The rusted out vent box under the house.

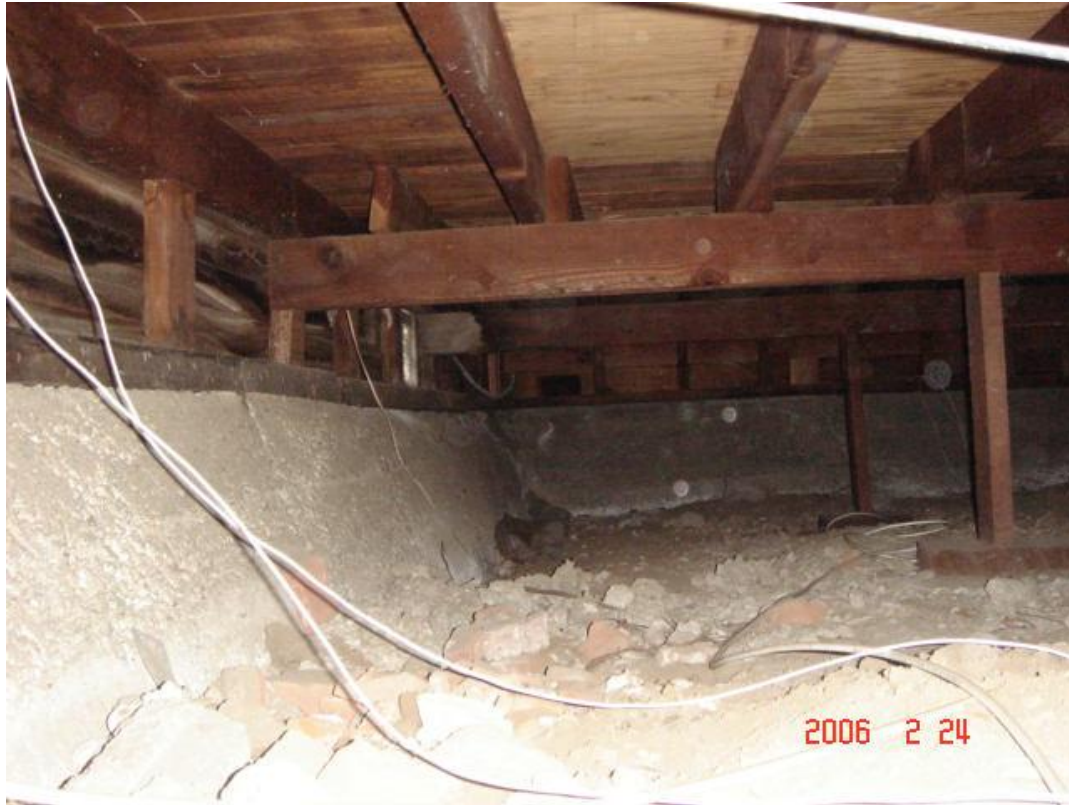
1. Most areas of the foundation have no foundation bolts. These bolts hold the wood wall framing sill plate to the concrete footings. These bolts can reduce damage to the building from earthquakes. For more information contact a foundation contractor.

2. This building has short walls under the house known as "cripple walls" These 2x4 walls under the house could be at risk during an earthquake. Plywood nailed to the sides of these walls will strengthen them. For further details contact a foundation contractor.

Lack of bolting, cripple walls and cracking to the foundation.
