# Apple Home Inspection

## Property Inspection Report

Property Address: ..... Fiji Way #D M.D.R.

Scope: Limited Visual Inspection

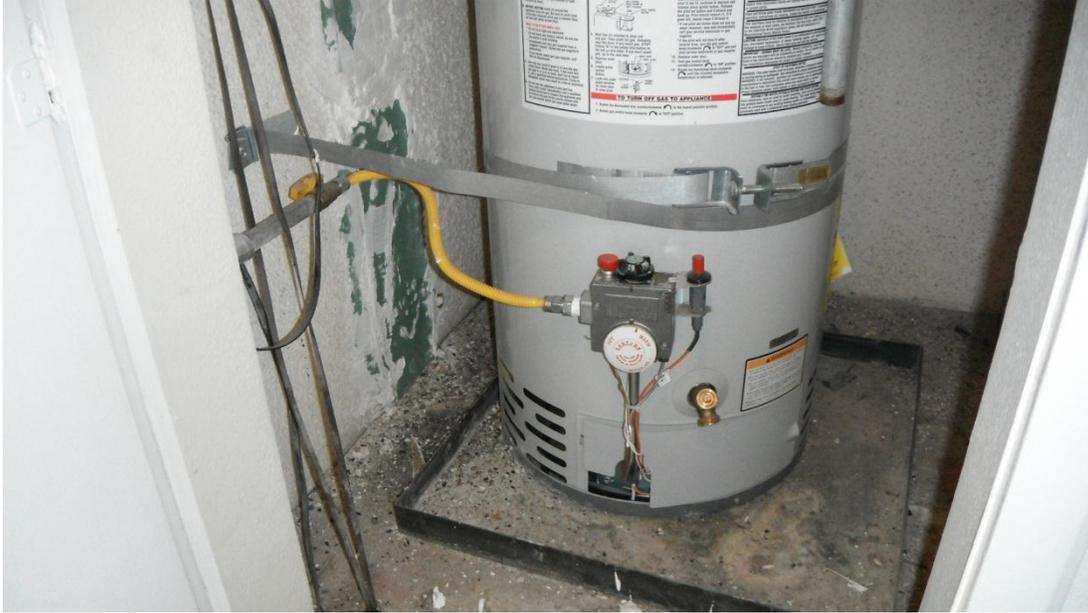
6. The hot water tank t/p discharge pipe is threaded at the end and should not be. This pipe should also extend to the exterior of the building. I was not able to determine if the pan under the tank is drained to the exterior.

The hot water tank

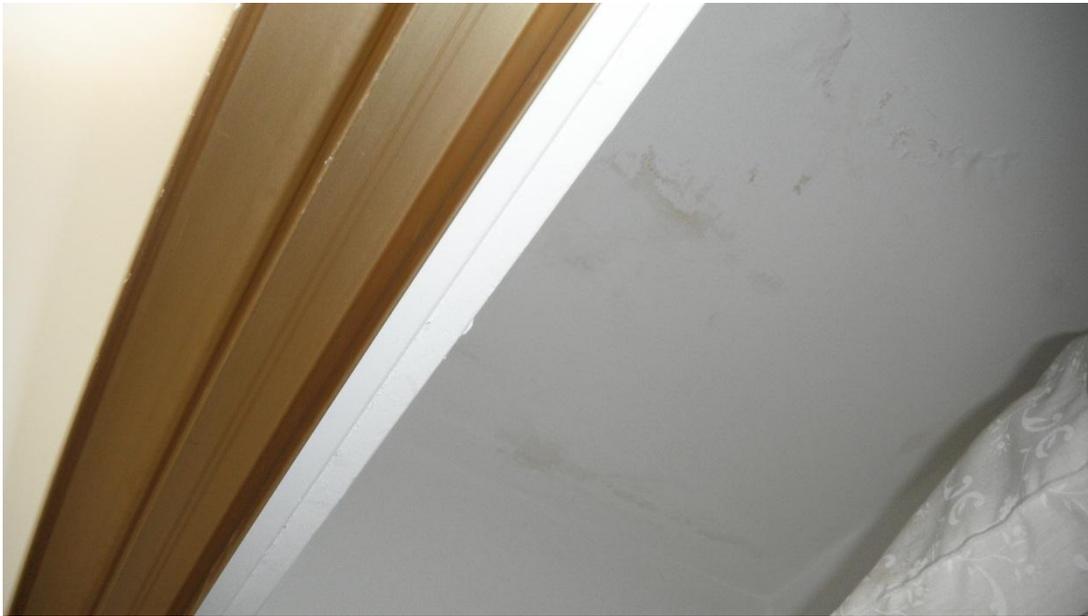
22. The listing agent discloses that the master bedroom upper east facing windows may leak at times of rain. He disclosed that the condo association is considering replacing all of these windows in the complex. Check on this with the h.o.a.

Water leakage at the master bedroom window.

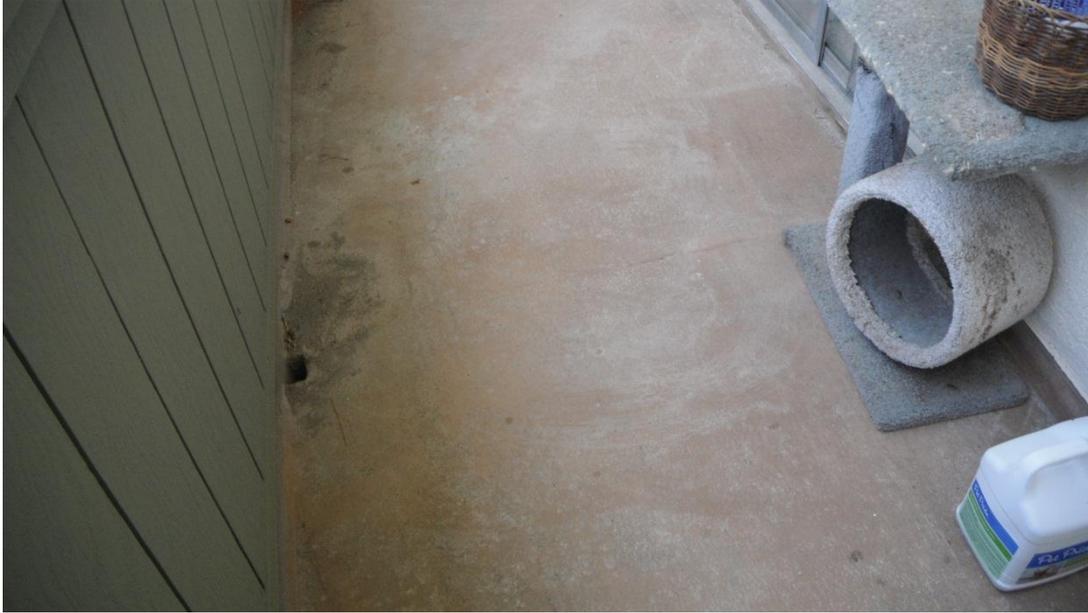
Cracks in the upstairs master bedroom exterior deck area.

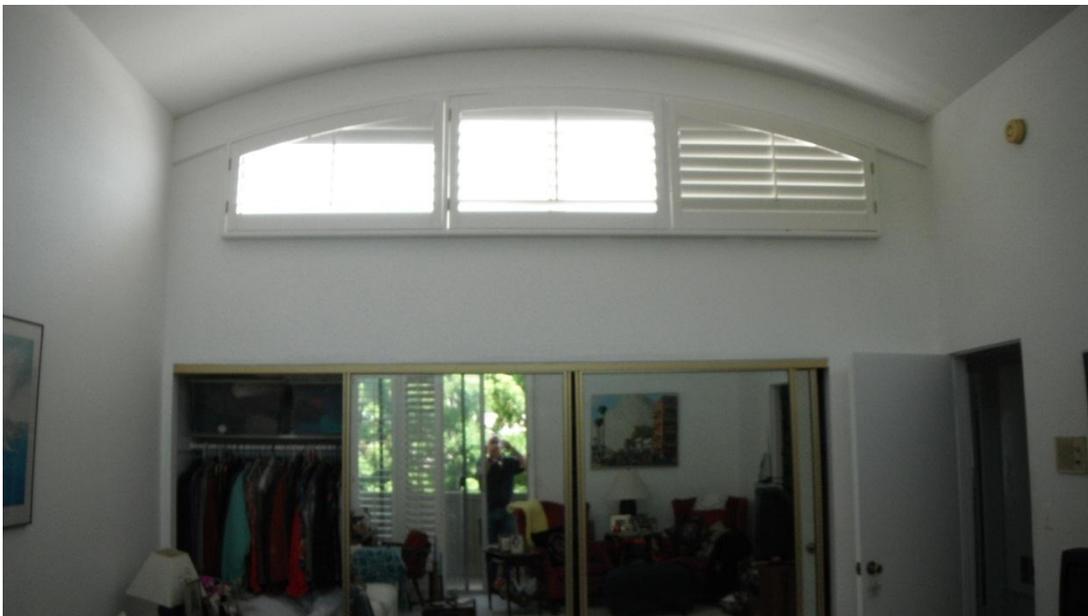
The window area that may be leaking, check with the h.o.a.

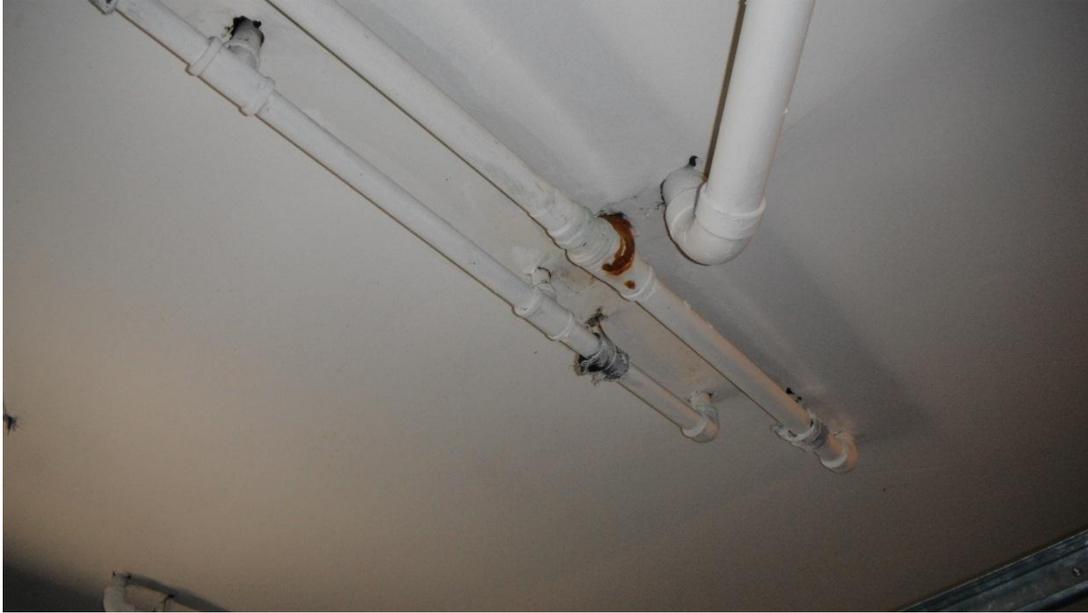
4. Water pipe is currently leaking in the attic area above the entry and in the garage storage area.
5. The strap around the hot water tank needs bracing between the wall and tank to prevent movement.

Leakage in the garage area galvanized pipes.

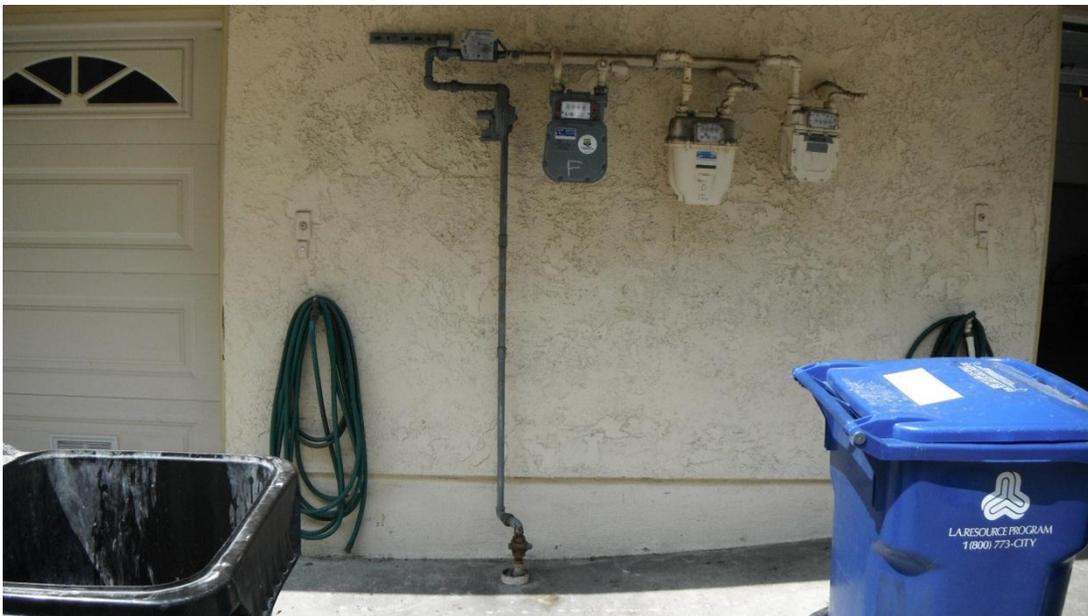
13. The gas pipes in the alley are not protected from car damaged. Check with the h.o.a. about this condition.

Gas pipes that need protection.

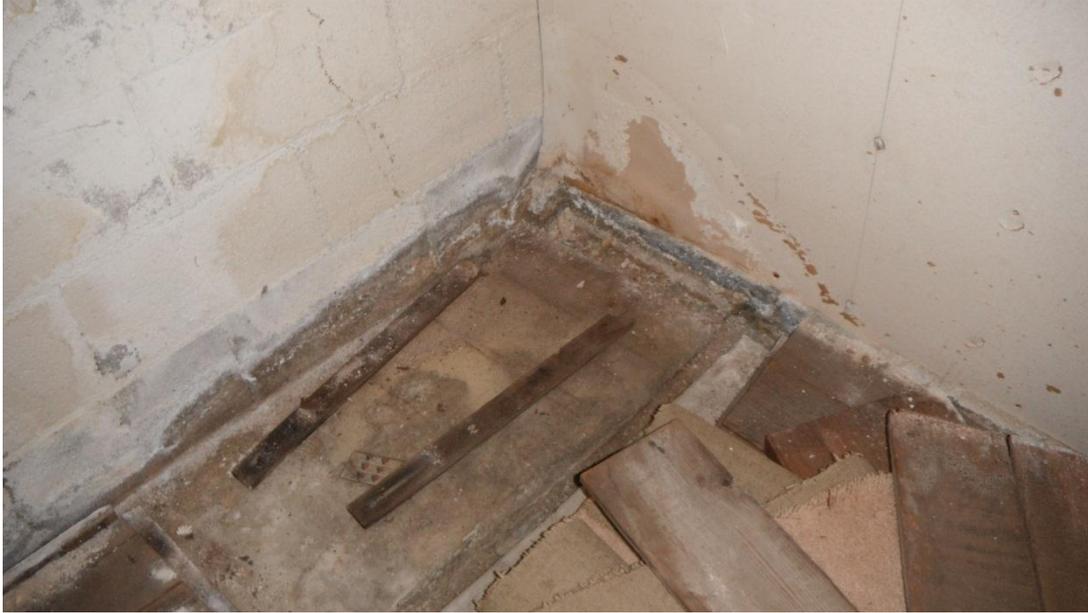
1. There is evidence of water seepage in the lower rear garage storage area. Some areas of drywall are water damaged and need to be removed and replaced. Water leakage may cause mold or mildew. This is not a mold report, which is done by others who may be qualified in this field.

Underground water seepage. Check with the h.o.a.

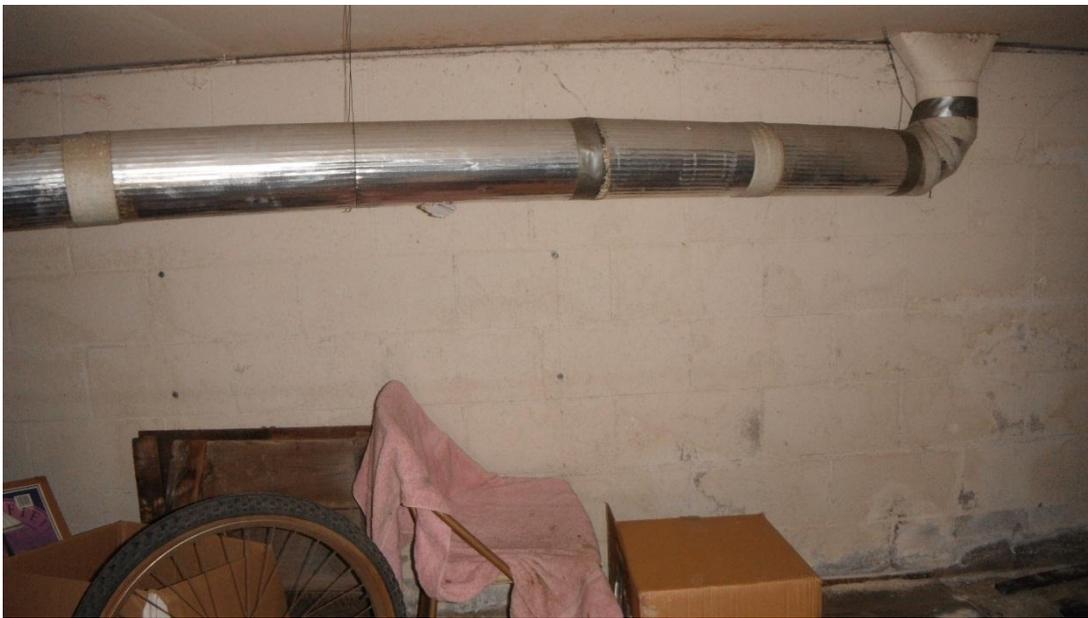
15. Insulation around heating ducts is asbestos material. Have the material removed as needed. The tin ducts under the asbestos appears secure with no open connections.
16. The flexible plastic gas connector is not protected from the sharp metal frame of the furnace as required. A simple rubber ring is needed.

Asbestos insulation around heating pipes.

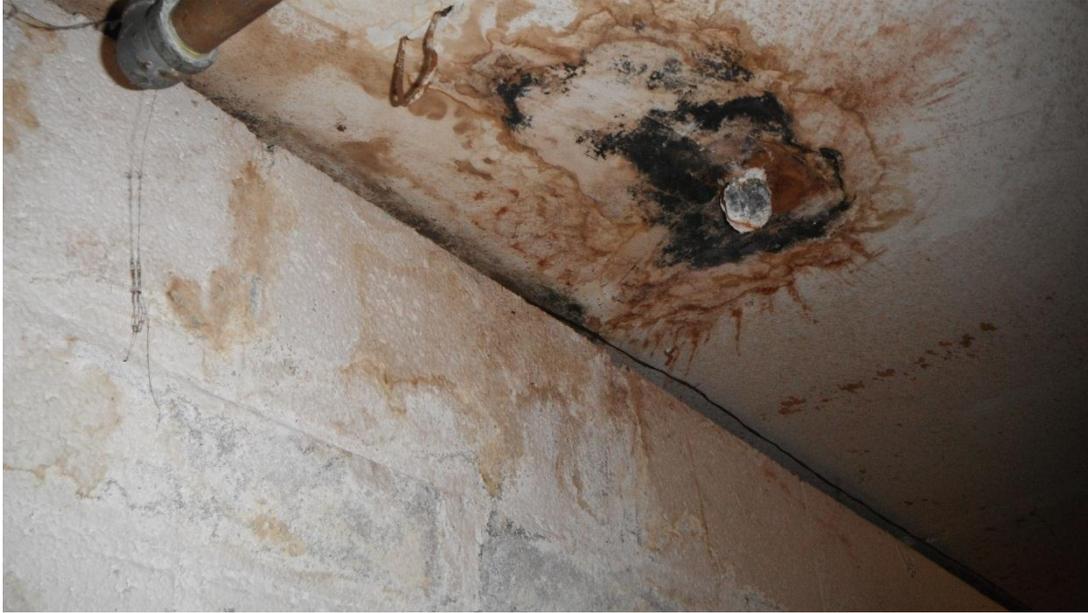
Galvanized water pipe leakage in the garage storage area.

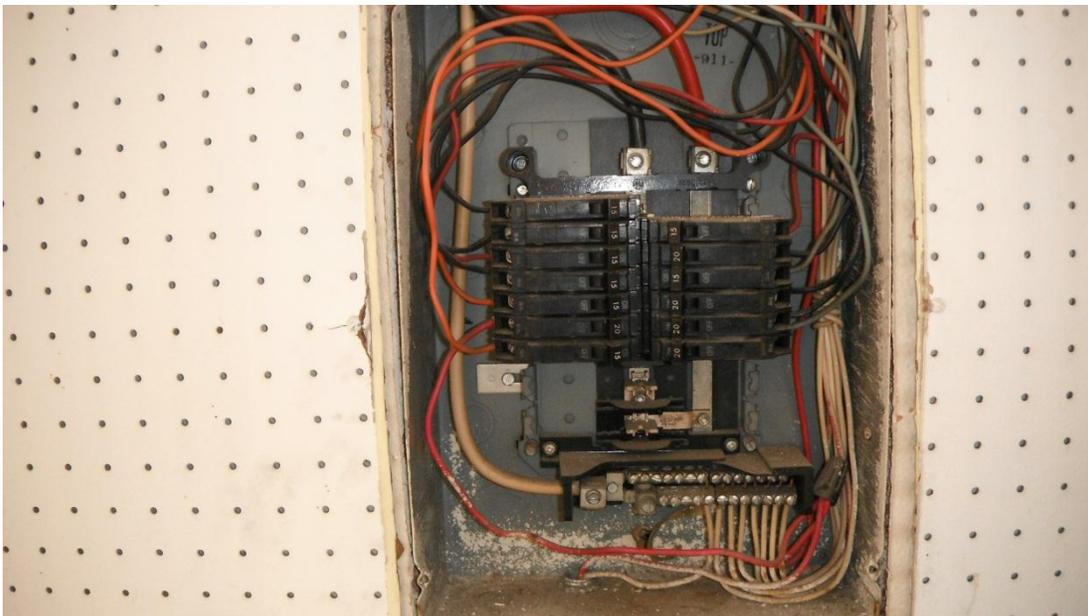
The electrical panel in good condition.

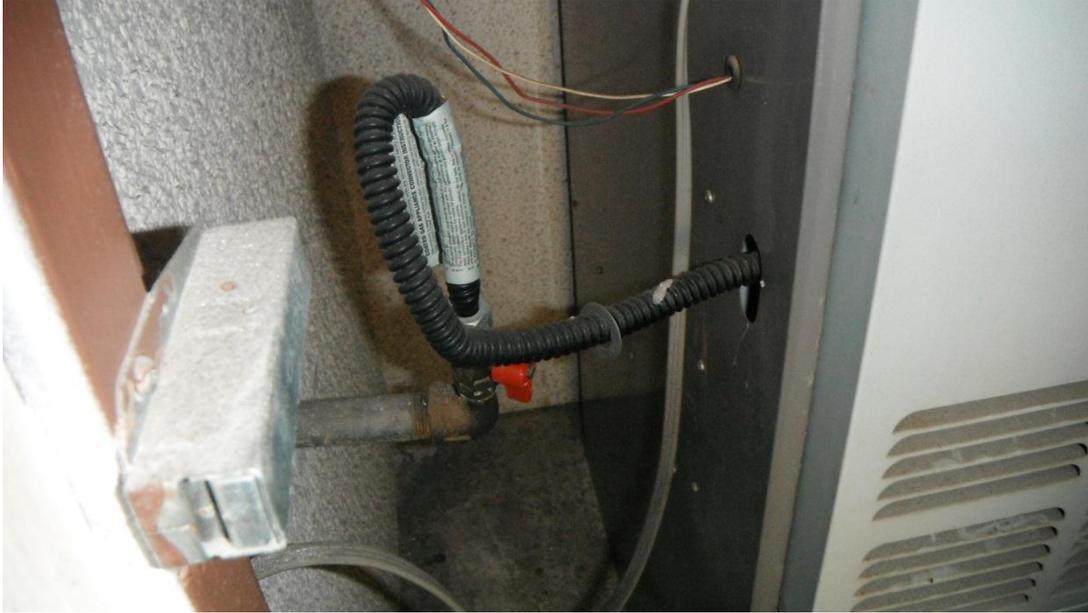
The furnace and flexible connector that is not protected.

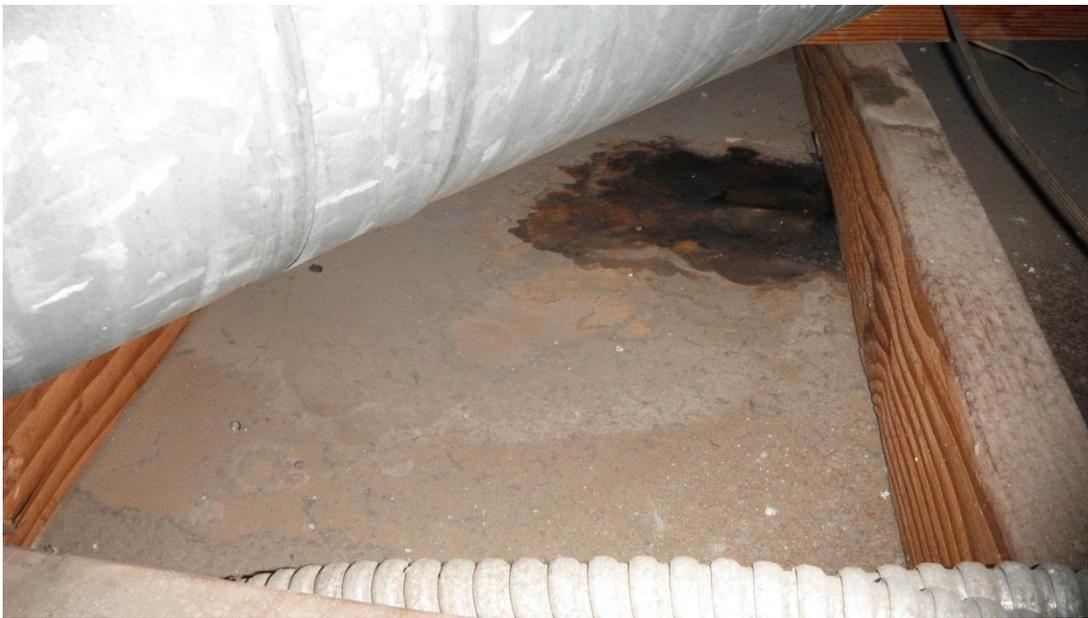
A leaking water pipe in the attic above the entry.
