Apple Home Inspection

Property Inspection Report

Property Address: 123 Main St. Santa Monica

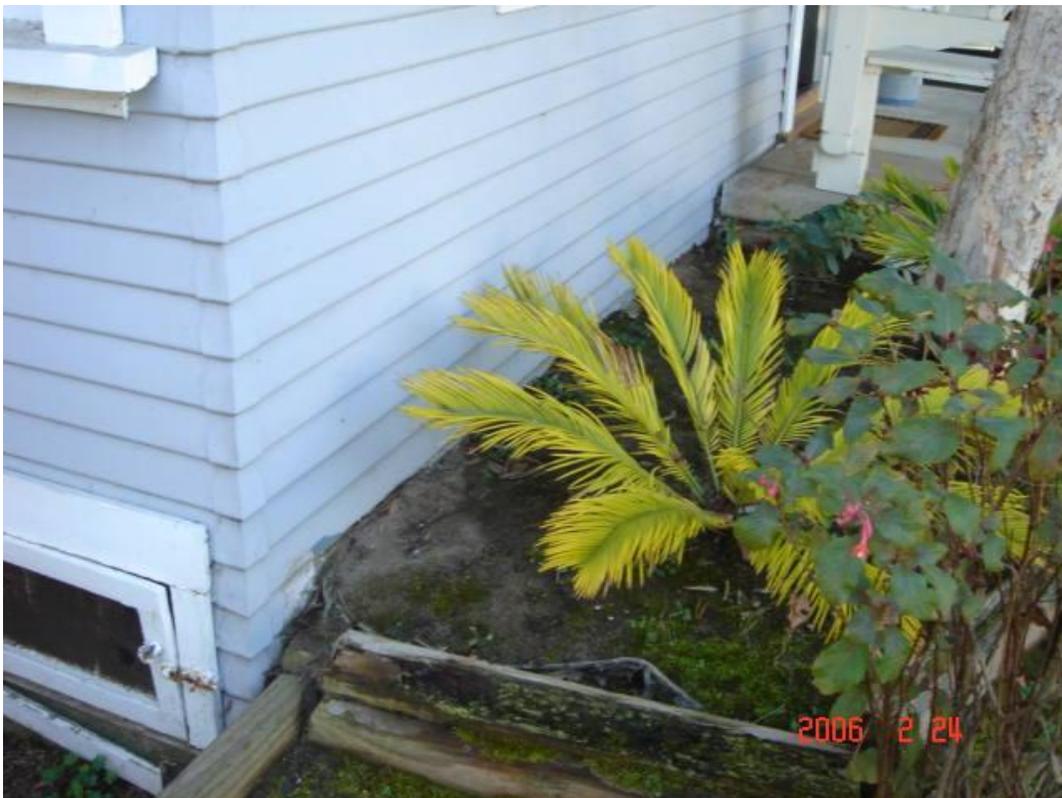
6. The planter box area at the front of the house is against the side of the house. There should be a two inch gap to prevent possible rot damage to the side of the house.

7. The wood siding of the house is painted wood. At this time period, lead paint was used. Lead paint is considered a hazard, read about lead paint hazards.

The planter box too close to the wood siding. (lead paint?)

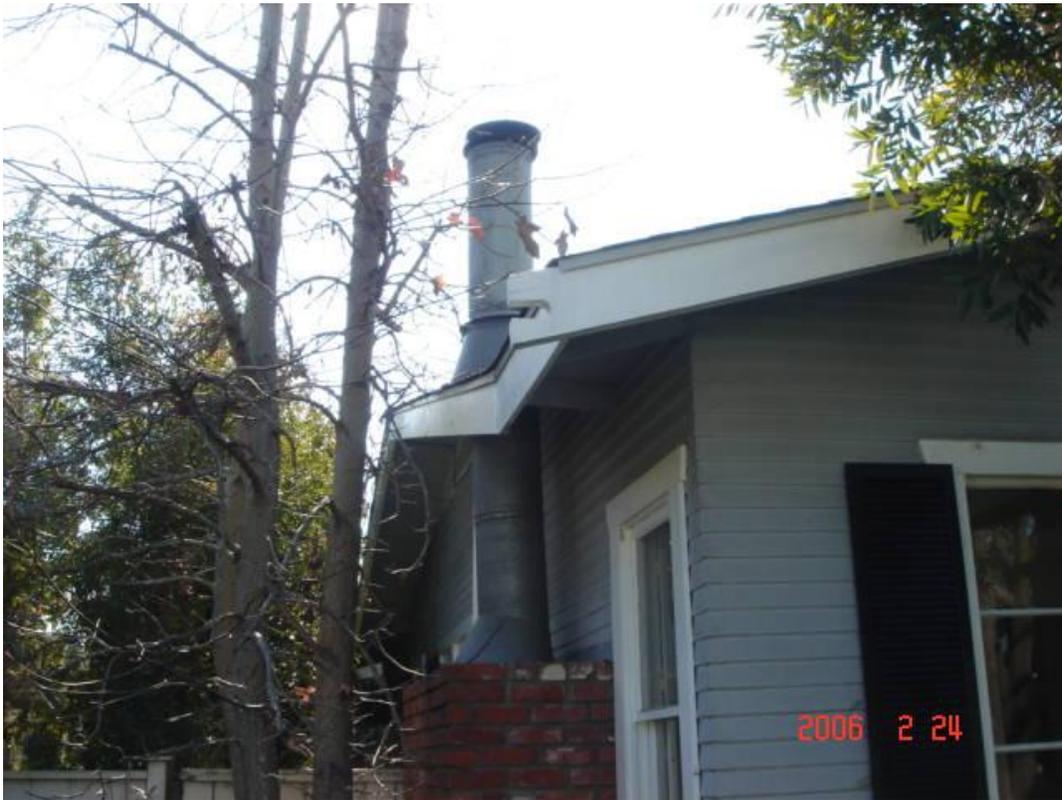
27. Tree limbs are burnt or charred next to the fireplace top, have the adjacent tree cut back or removed.
28. The gap where the gas pipe extends through the fireplace firebox wall needs to be sealed with a special high temperature grout. This will prevent the possibility of sparks entering back behind the wall where combustible material may be.

The fireplace and tree to close to the spark arrester.

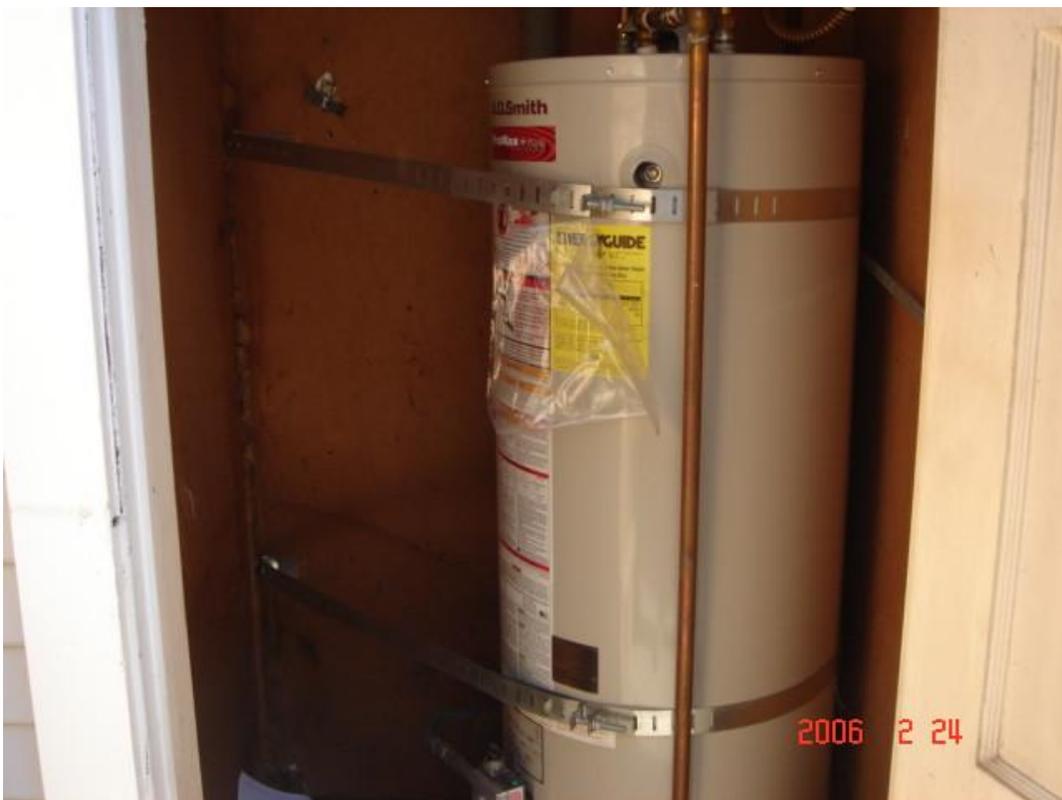
The earthquake strap to wide around the tank.

19. The earthquake strap around the hot water tank is improper. The wide angle of the strap will not keep the tank from moving side to side.

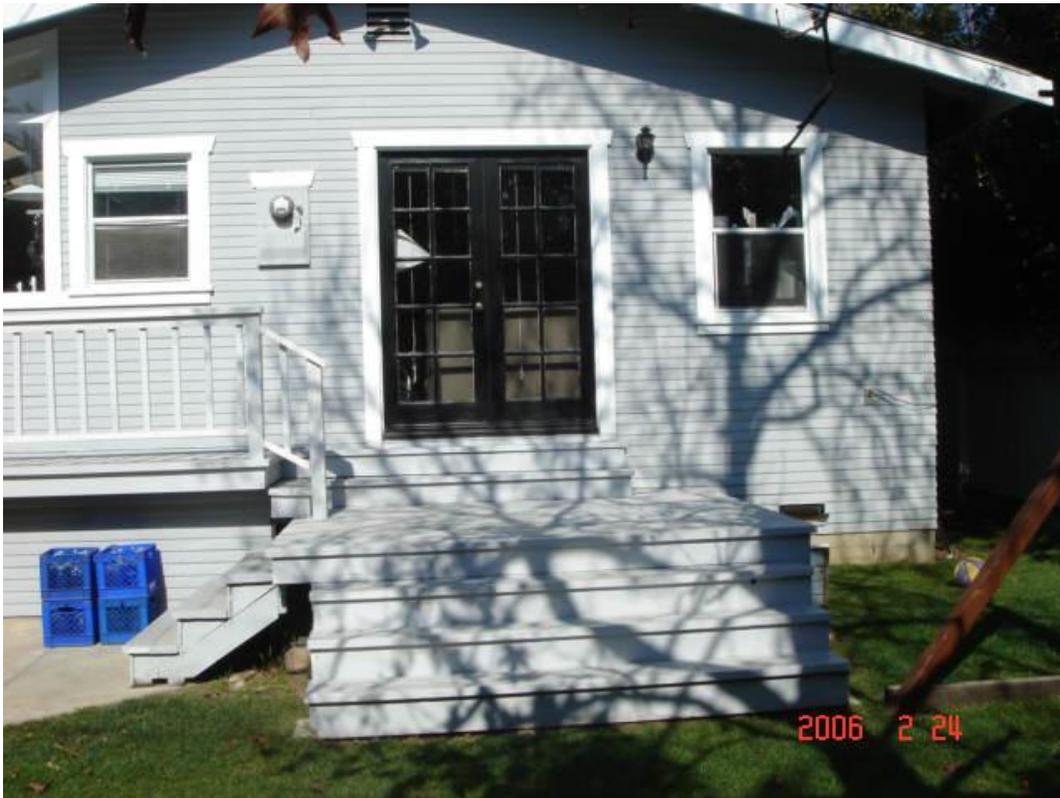
The rear view of the house. The deck is under 30 inches, no guardrail required.

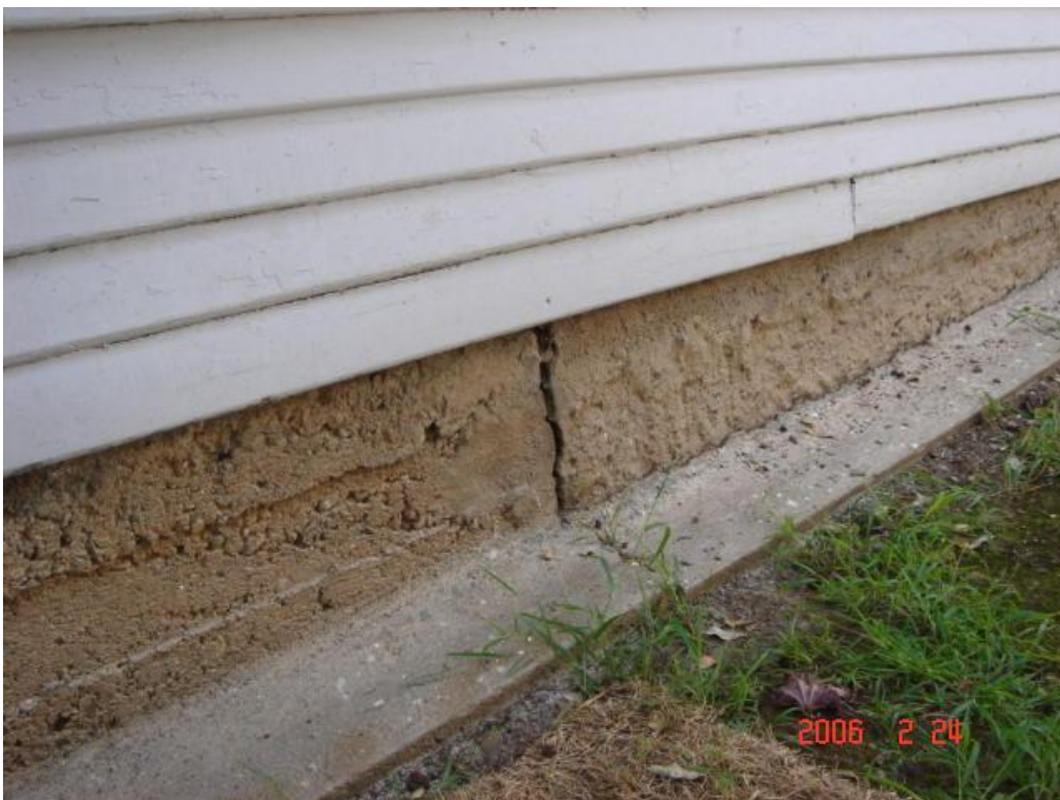
4. The sill plate is loose from along the rear east foundation. There are several vertical cracks in the concrete foundation.
5. Have a foundation contractor, engineer or trades person, further inspect, comment, make recommendations and repair or replace as may be needed.

A crack in the concrete footing.

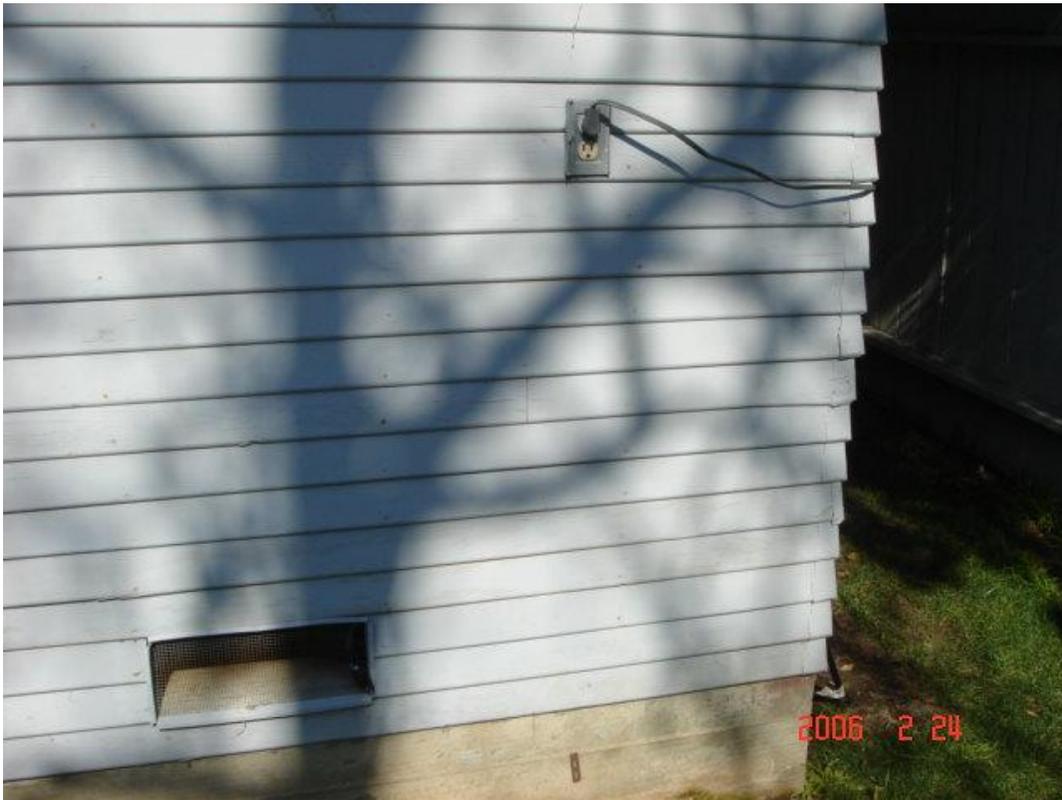
The unprotected outlet and wire at the foundation vent needing a box.

24. The outside sprinkler timer is plugged into an interior type outlet that is not weather or rain protected. There is an electrical wire extension coming out of a foundation vent

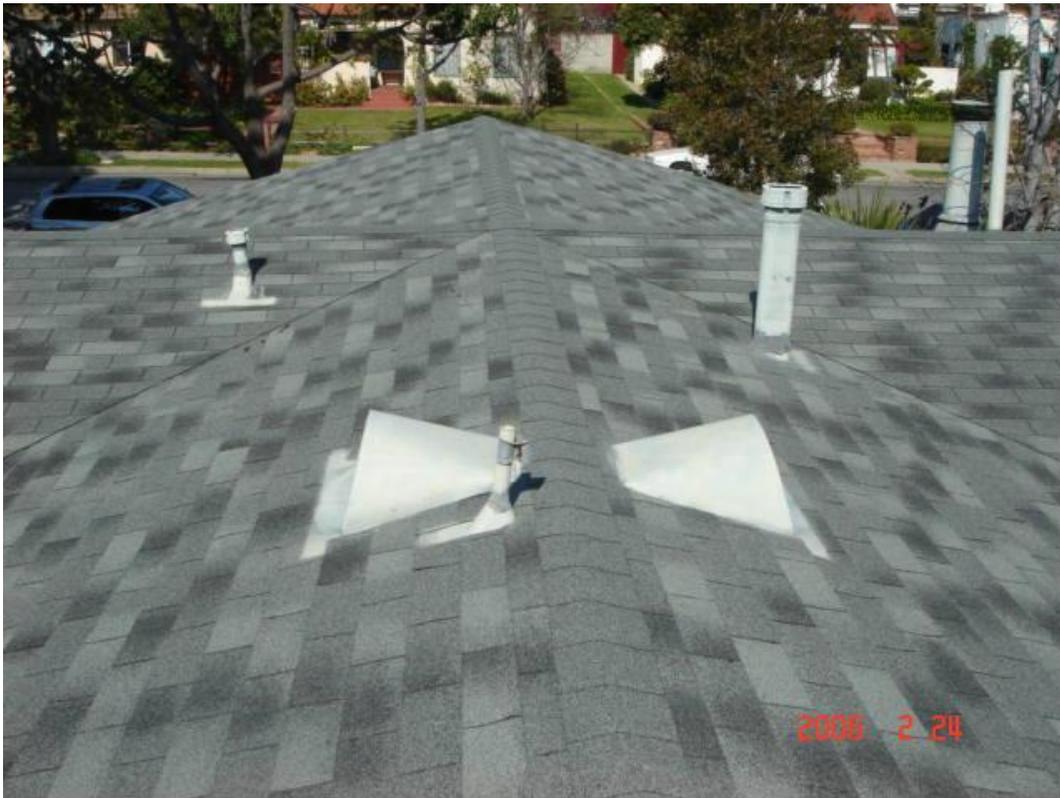
The roof in good condition.

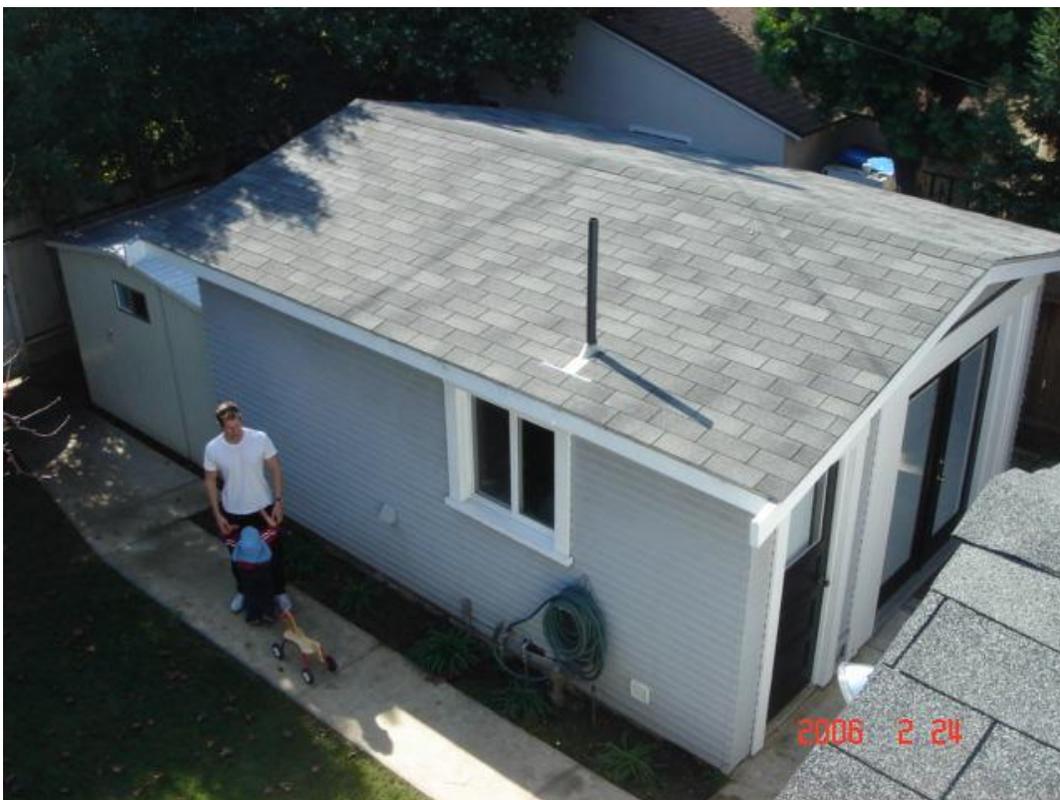
10. The garage has been converted to a living area. Usually a garage is required for zoning and city requirements. The interior floors slope out of level. I was not able to view under the floor to report on possible cracking or rot damage. The driveway slopes towards the converted garage and may pond water underneath. The floor would have to be removed to know or view problems.

The converted garage.

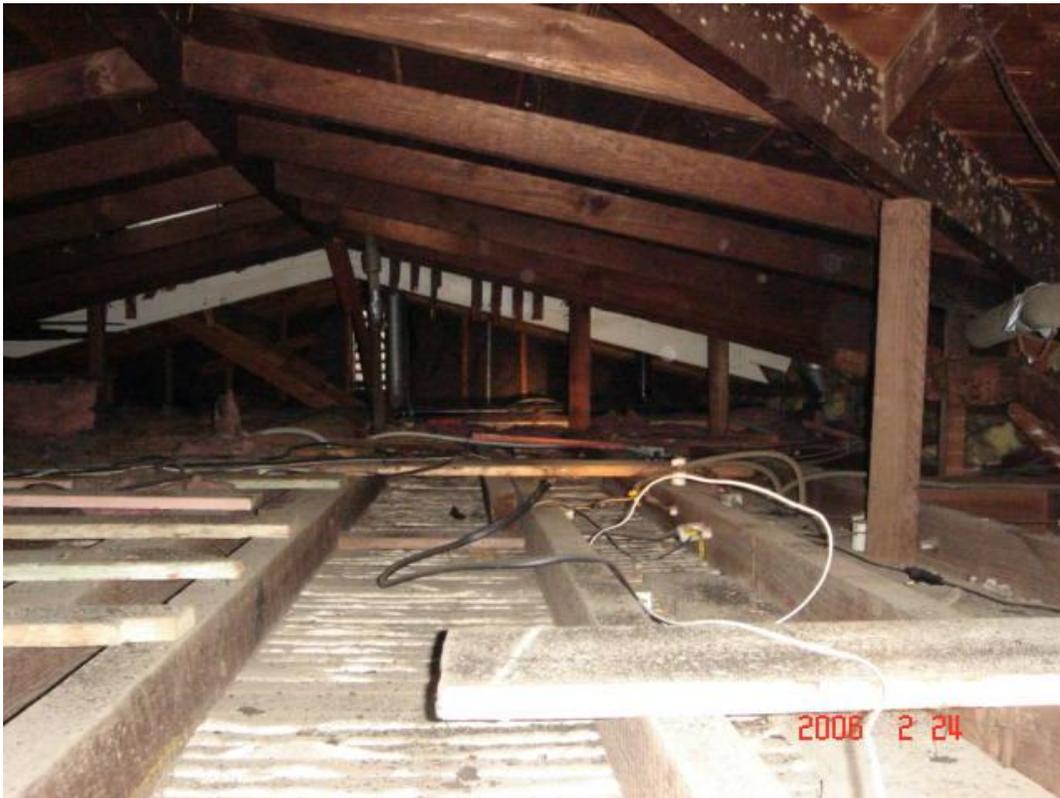
22. There is knob and tube wiring in the house (attic and foundation) This type of wiring is old and consists of wires separated by an air space and mounted between porcelain insulators. There is no protective conduit (pipe or sheathing protection) This type of wiring can easily be damaged and is not considered safe. Knob and tube wiring should never be covered with insulation, because the heat in the wire can't dissipate. Electricians usually recommend the removal of this type of wiring. Check with an electrician.

The attic, no insulation. Knob and tube wiring needing replacing.

- ✓ The attic area from below the roof to above the ceilings were viewed. Wood framing and ventilation were checked and found to be in sound or satisfactory overall condition, unless other wise noted. There is no insulation. The visible portions of the framing are in acceptable condition, and would conform to the standards of the year in which they were constructed.
- ✓ I was able to access and view the attic by walking or crawling in.
- ✓ The attic access is in the bedroom hall ceiling. The opening size is adequate.

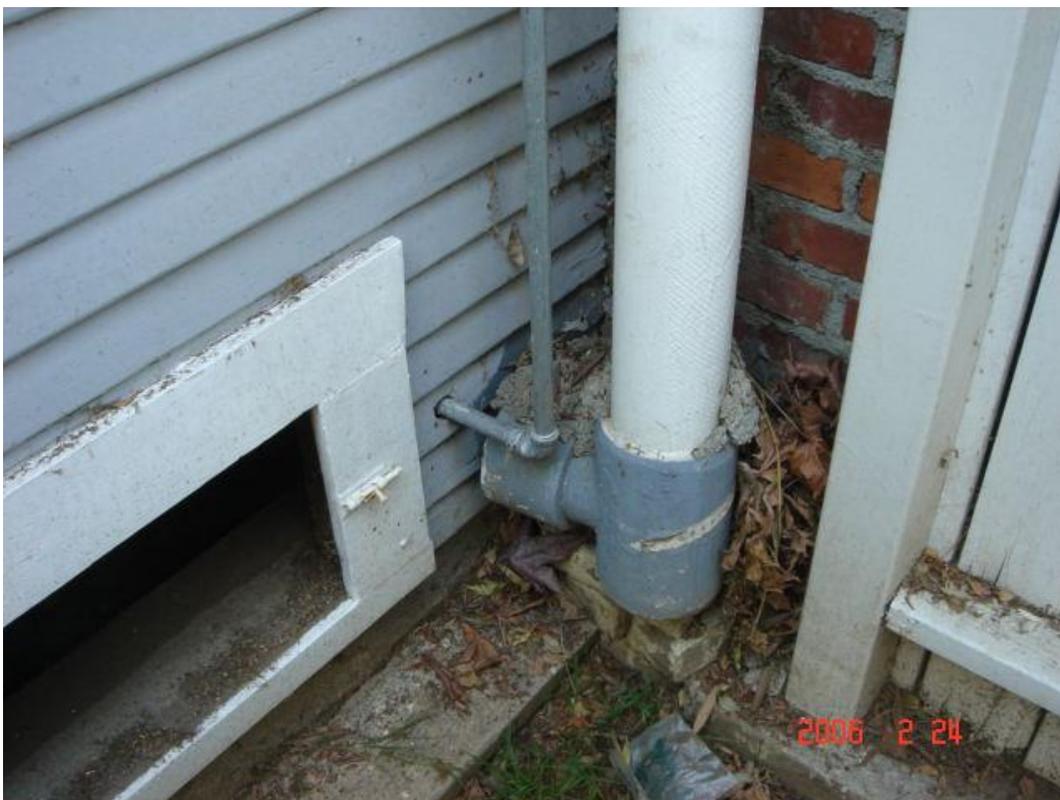
25. The vent box attached to the floor furnace in the front room is rusted open. All products of combustion dissipate under the house and seep up to the living area above. This could be a hazard. The transite asbestos vent pipe is disconnected at the side of the house by the fireplace. Have a plumber check and repair as needed. This is a safety or hazard condition.

The disconnected floor furnace vent pipe by the fireplace.

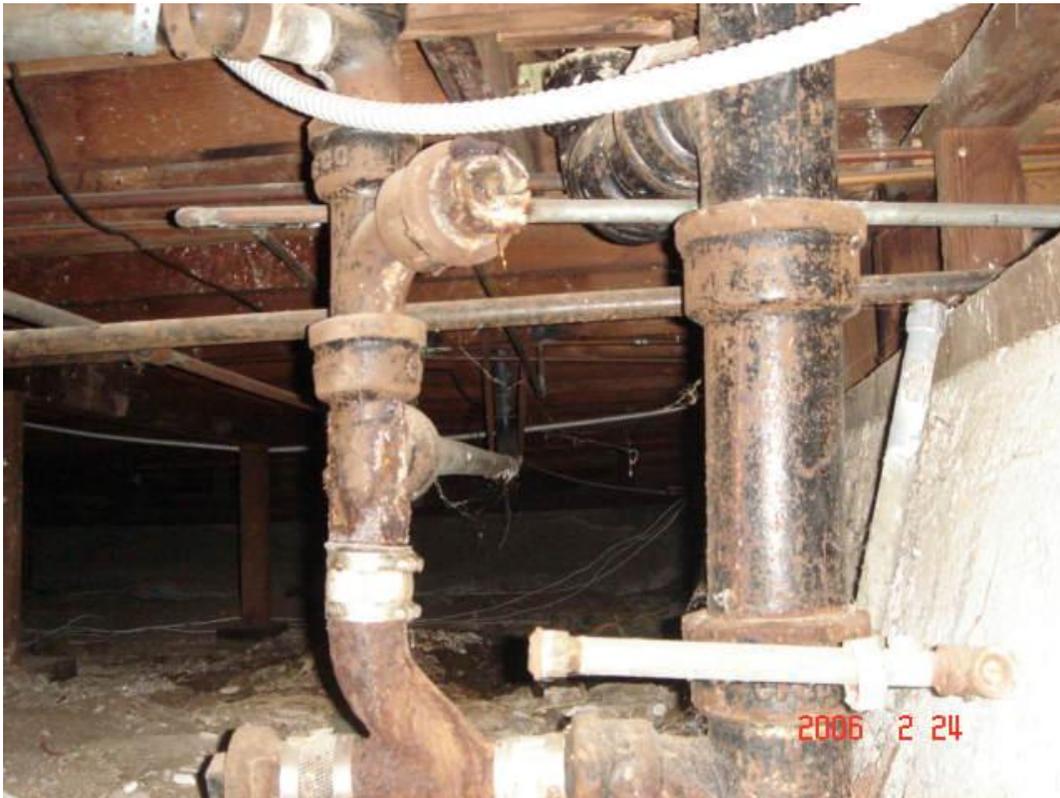
15. There are leaking corroded sections of plumbing drain pipe as viewed from under the house. Plumbing pipe fittings are not properly connected under the rear master bathroom. The drain lines above and under ground appear original and possibly in need of replacing. Have a qualified plumbing contractor or trades person, further inspect, comment, make recommendations and repair or replace as may be needed.

A section of corroded drain pipe.

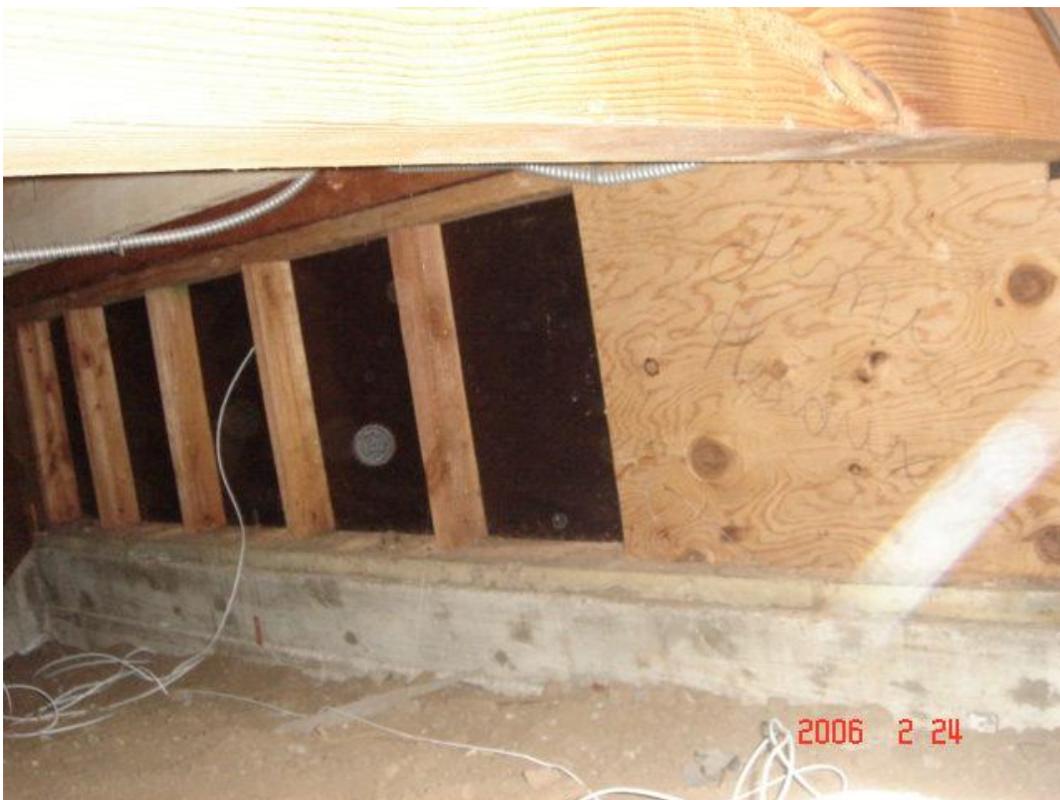
3. Some cripple walls have been added under the rear addition of the house. The cripple walls have been improperly installed. There is no blocking, some sections are loose.

Partial incorrectly installed shear wall support.

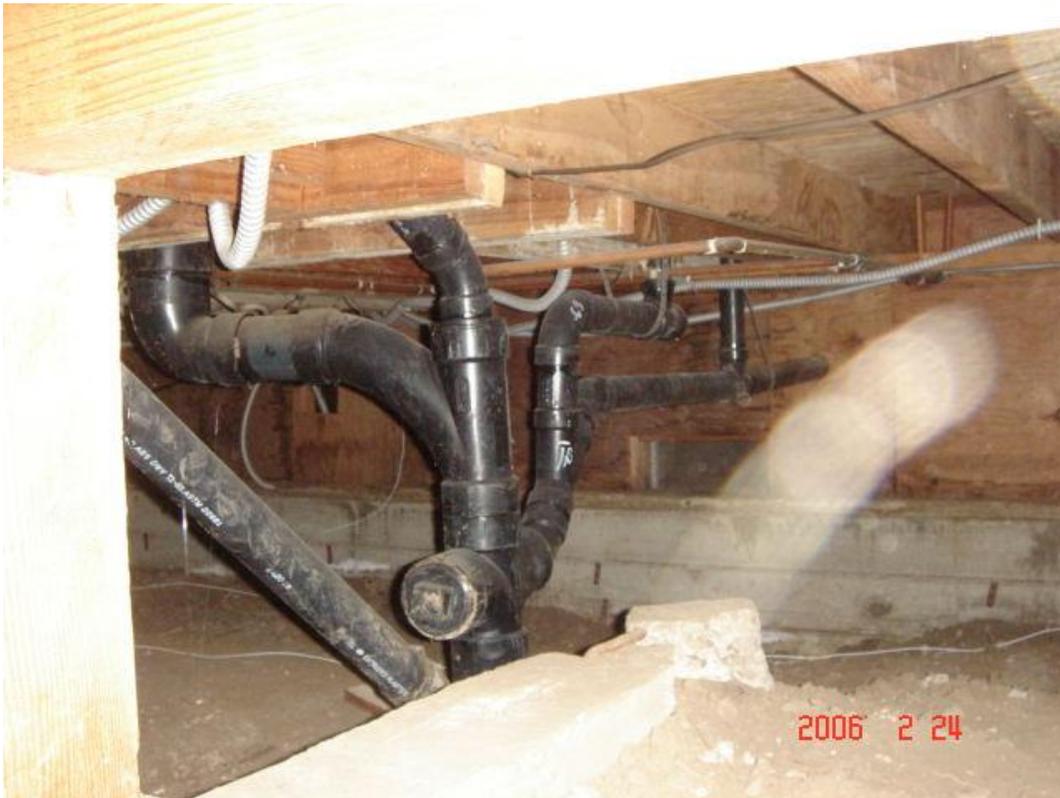
Improper drain fittings under the master bathroom.

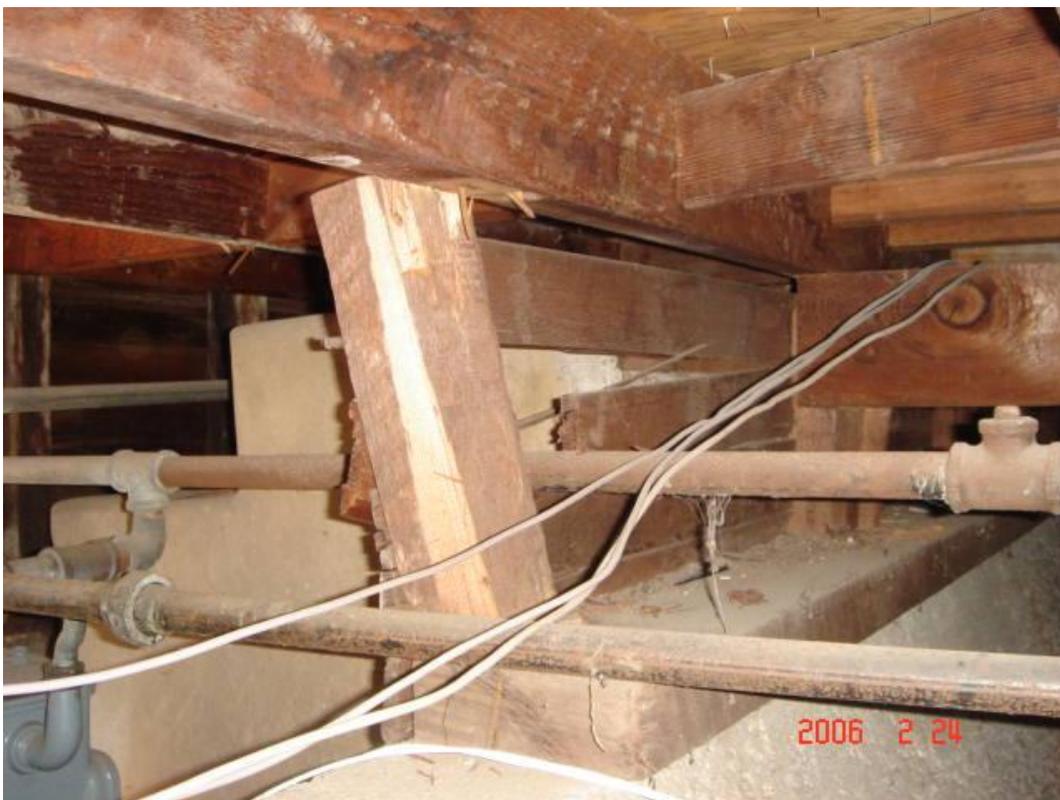
Loose cripple wall support.

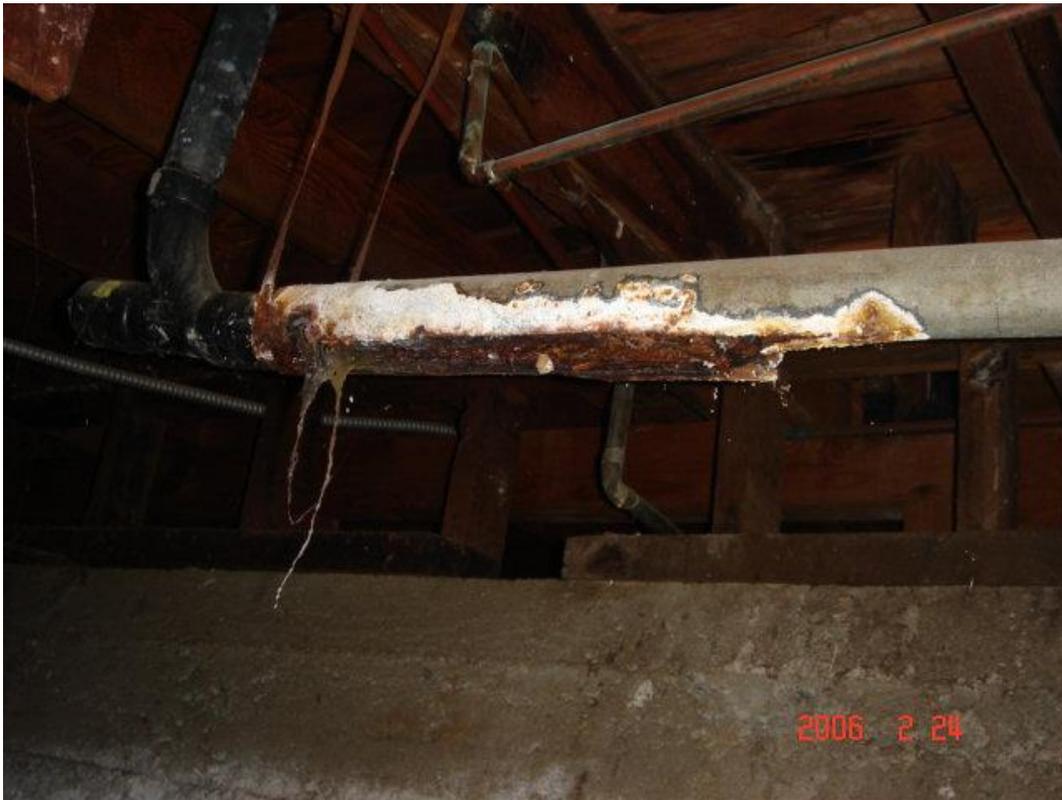
Corroded drain pipe, leaking to under the house.

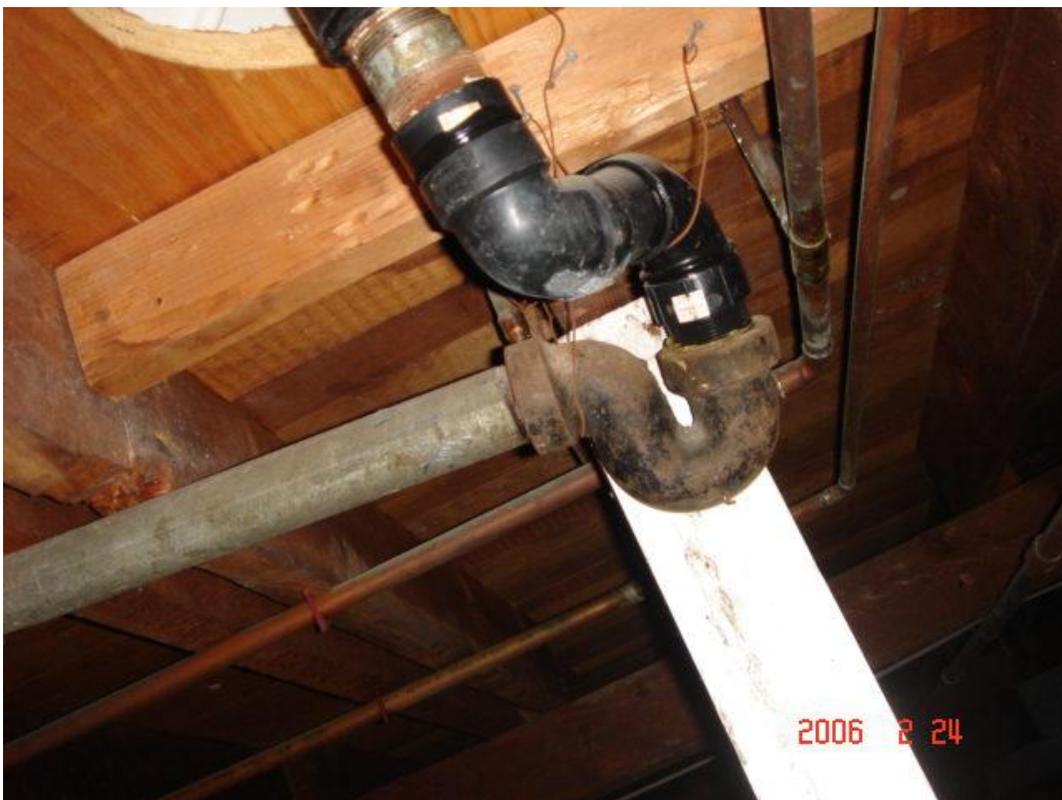
Improper drain fitting under the hall bathroom.

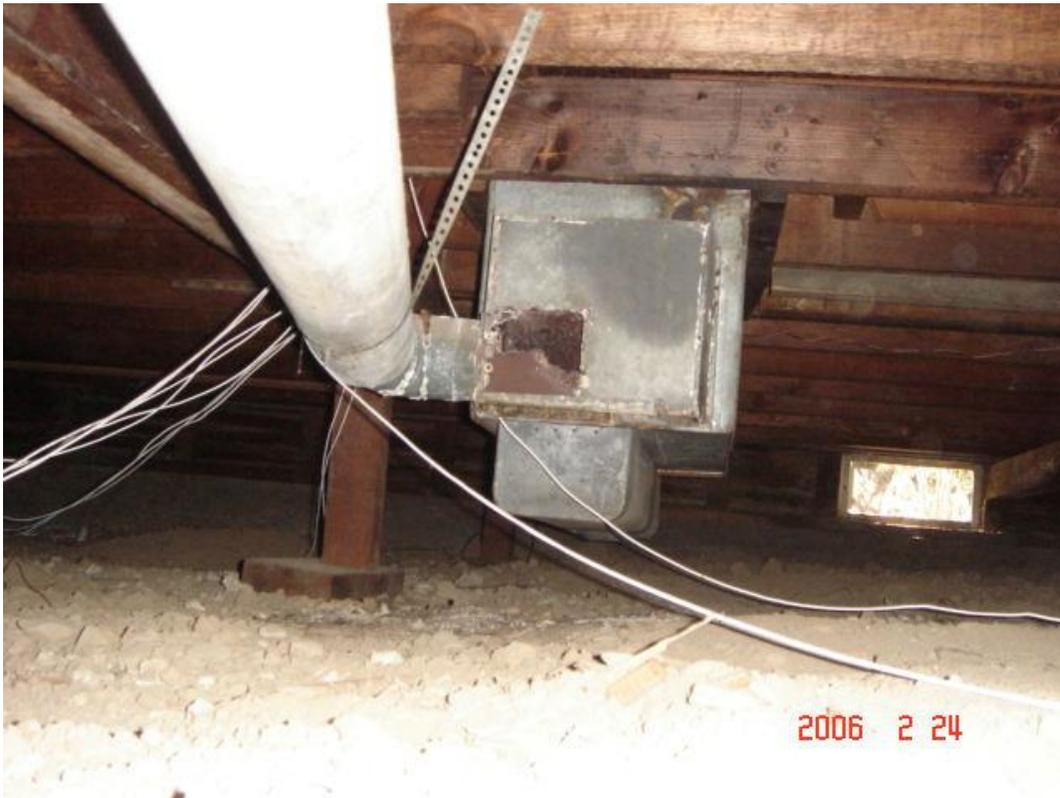
The rusted out vent box under the house.

- ✓ Floor furnace: This is a metal enclosed box installed below the floor. Heat from the gas burners radiates upward. The vent box is rusted out and the vent by the outside of the building is disconnected.
- ✓ Wall furnace: Located on a wall, gas heat inside a metal box radiates outward. The heater was operated from its control and was found to be in good condition. The heater should be vacuumed out of lint or dust at least yearly

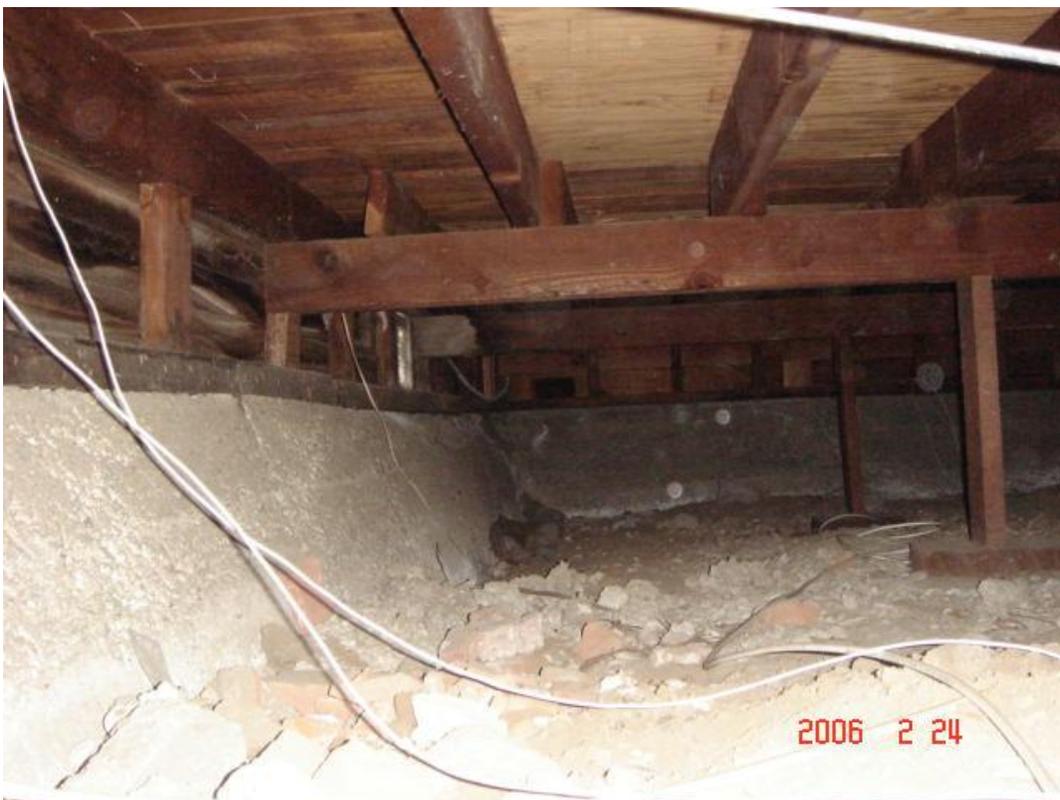
1. Most areas of the foundation have no foundation bolts. These bolts hold the wood wall framing sill plate to the concrete footings. These bolts can reduce damage to the building from earthquakes. For more information contact a foundation contractor.

2. This building has short walls under the house known as "cripple walls" These 2x4 walls under the house could be at risk during an earthquake. Plywood nailed to the sides of these walls will strengthen them. For further details contact a foundation contractor.

Lack of bolting, cripple walls and cracking to the foundation.
